CALIFORNIA COASTAL COMMISSION

W13c**STAFF REPORT: REGULAR CALENDAR****APPLICATION NUMBER:** 5-00-034**APPLICANT:** Mike McKinley and John Bass**AGENT:** Alan Block**PROJECT LOCATION:** 327 and 327 1/2 Paseo de Cristobal, City of San Clemente, Orange County

PROJECT DESCRIPTION: To permanently authorize the construction allowed under Emergency Permit 5-98-273-G for a new 110 foot long by twenty foot tall retaining wall with sixteen caissons on a coastal bluff and backfilling the area between the retaining wall and the landslide scarp with approximately 1600 cubic yards of material on two lots totaling 26,481 square feet. Re-landscaping the bluff below the retaining wall with native vegetation and the construction of new backyard hardscape on both lots.

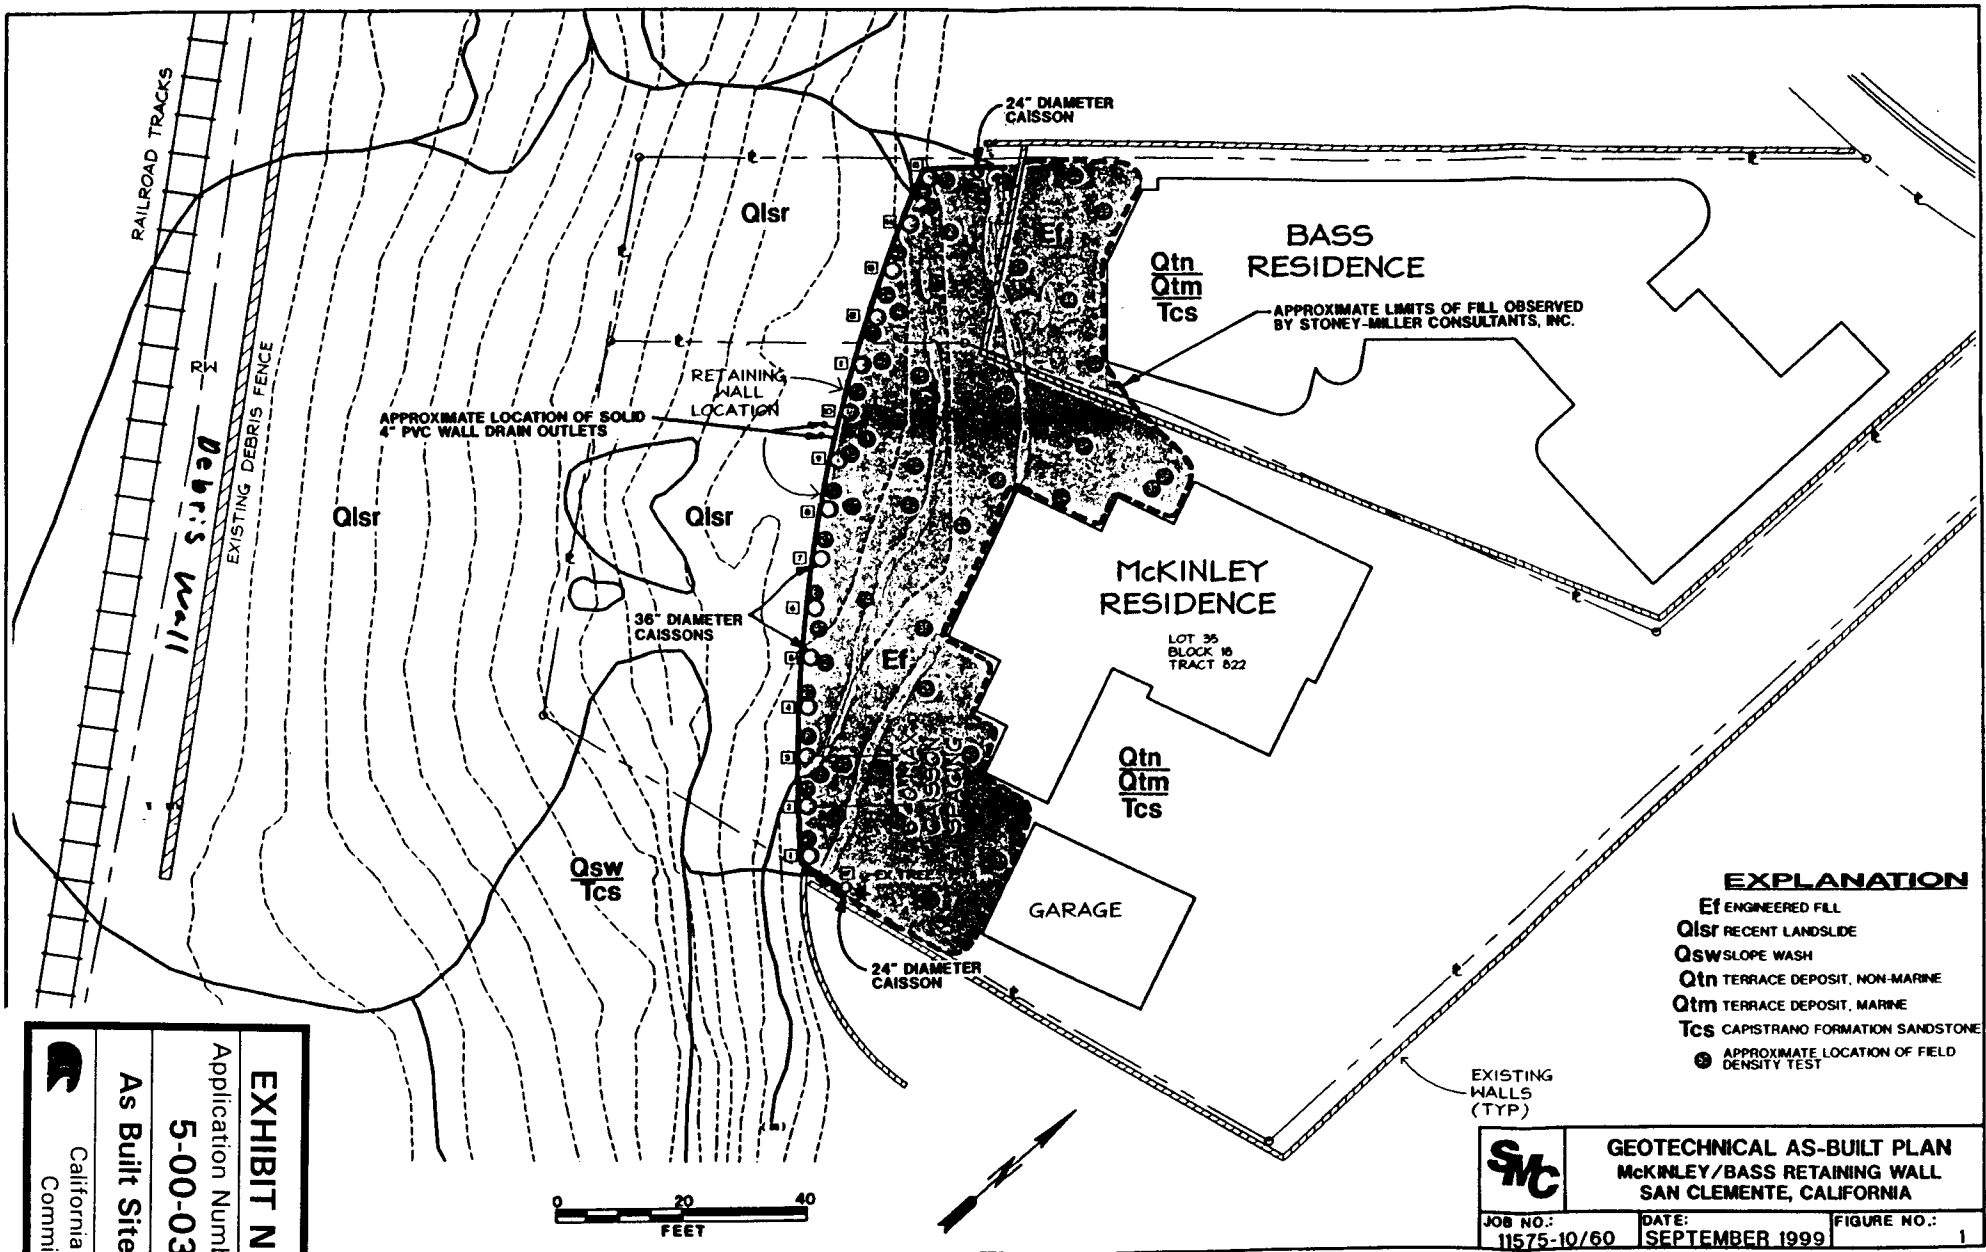
<p>California Coastal Commission</p>	EXHIBIT NO. 3
	Application Number: 5-00-034
	As Built Site Plan

GEOTECHNICAL AS-BUILT PLAN	
	McKINLEY/BASS RETAINING WALL	
SAN CLEMENTE, CALIFORNIA		
JOB NO.:	DATE:	FIGURE NO.:
11575-10/60	SEPTEMBER 1999	1

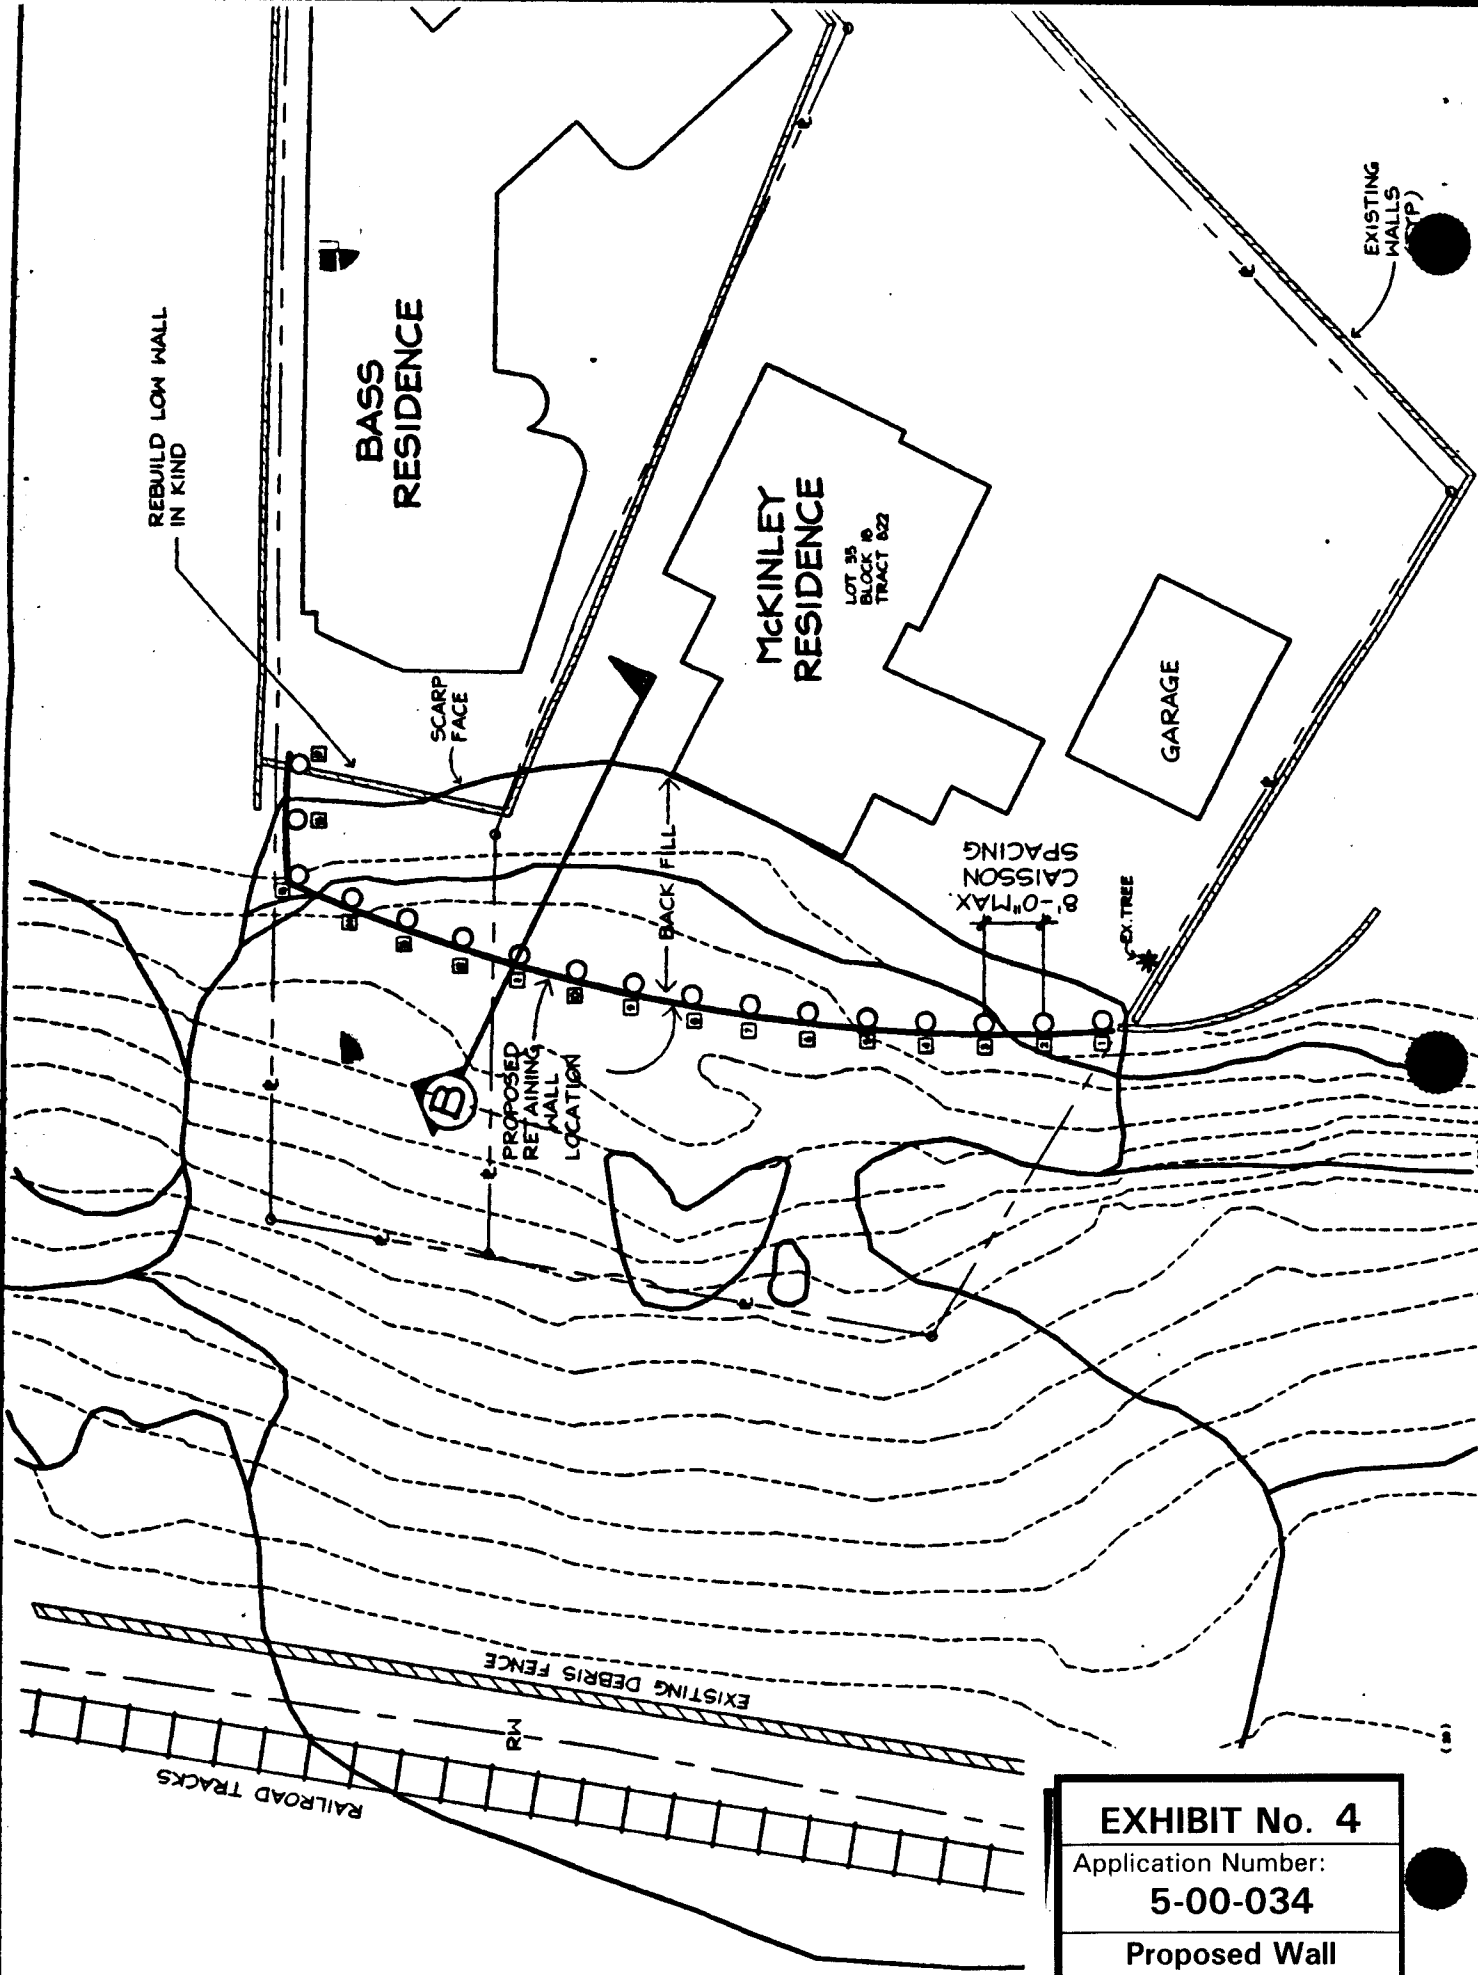
EXHIBIT No. 4
Application Number: 5-00-034
Proposed Wall
California Coastal Commission

REPLACEMENT FILL MATERIAL (CROSS HATCH AREA TO BE REMOVED PRIOR TO REPLACEMENT FILL)
-

CONCRETE CAISSON/SOLDIER PILE

VIEW NORTHWEST
N53°E →

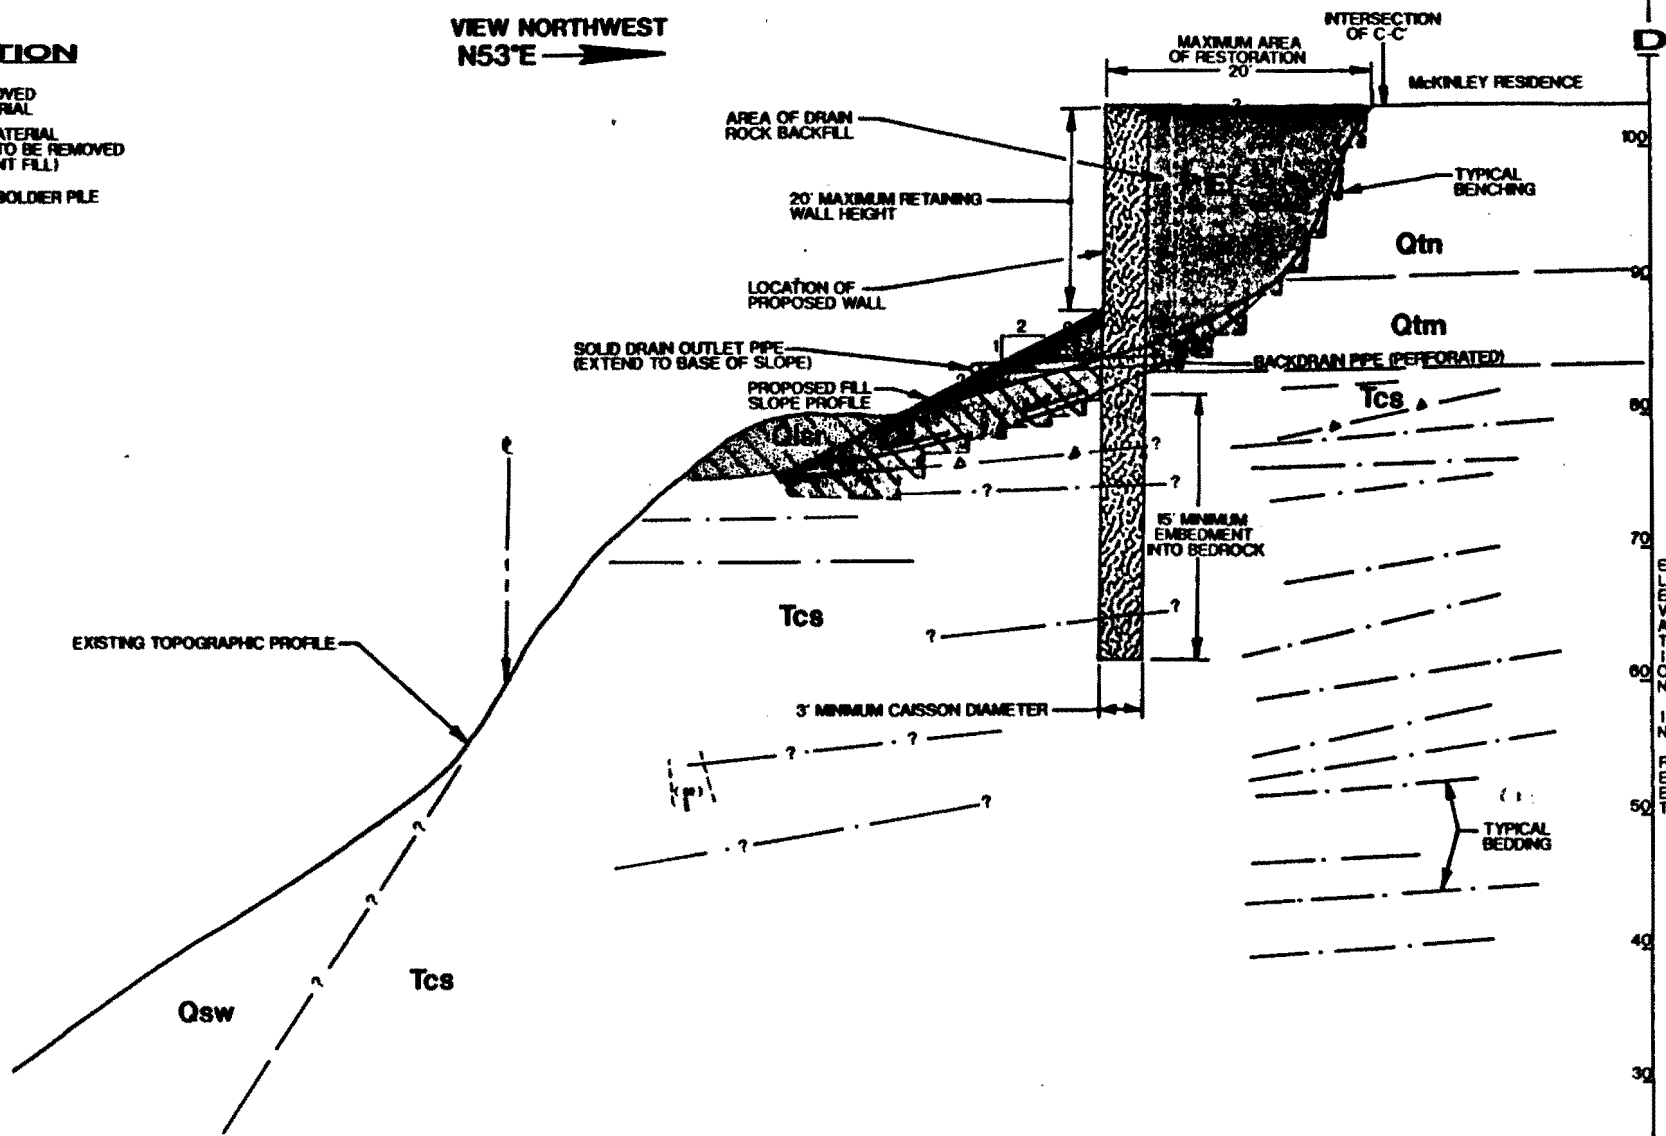
California Coastal Commission	Sectional View
	Application Number: 5-00-034
	EXHIBIT No. 5

REPAIR CROSS SECTION D-D'		
	327 & 327 1/2 PASEO DE CRISTOBAL SAN CLEMENTE, CALIFORNIA		
JOB NO.: 11575-00	DATE: MAY 1998	FIGURE NO.: 2

ENGINEERING WALL CONSTRUCTION CRITERIA TO BE PROVIDED BY STRUCTURAL ENGINEER.

SCALE - 1" = 20'

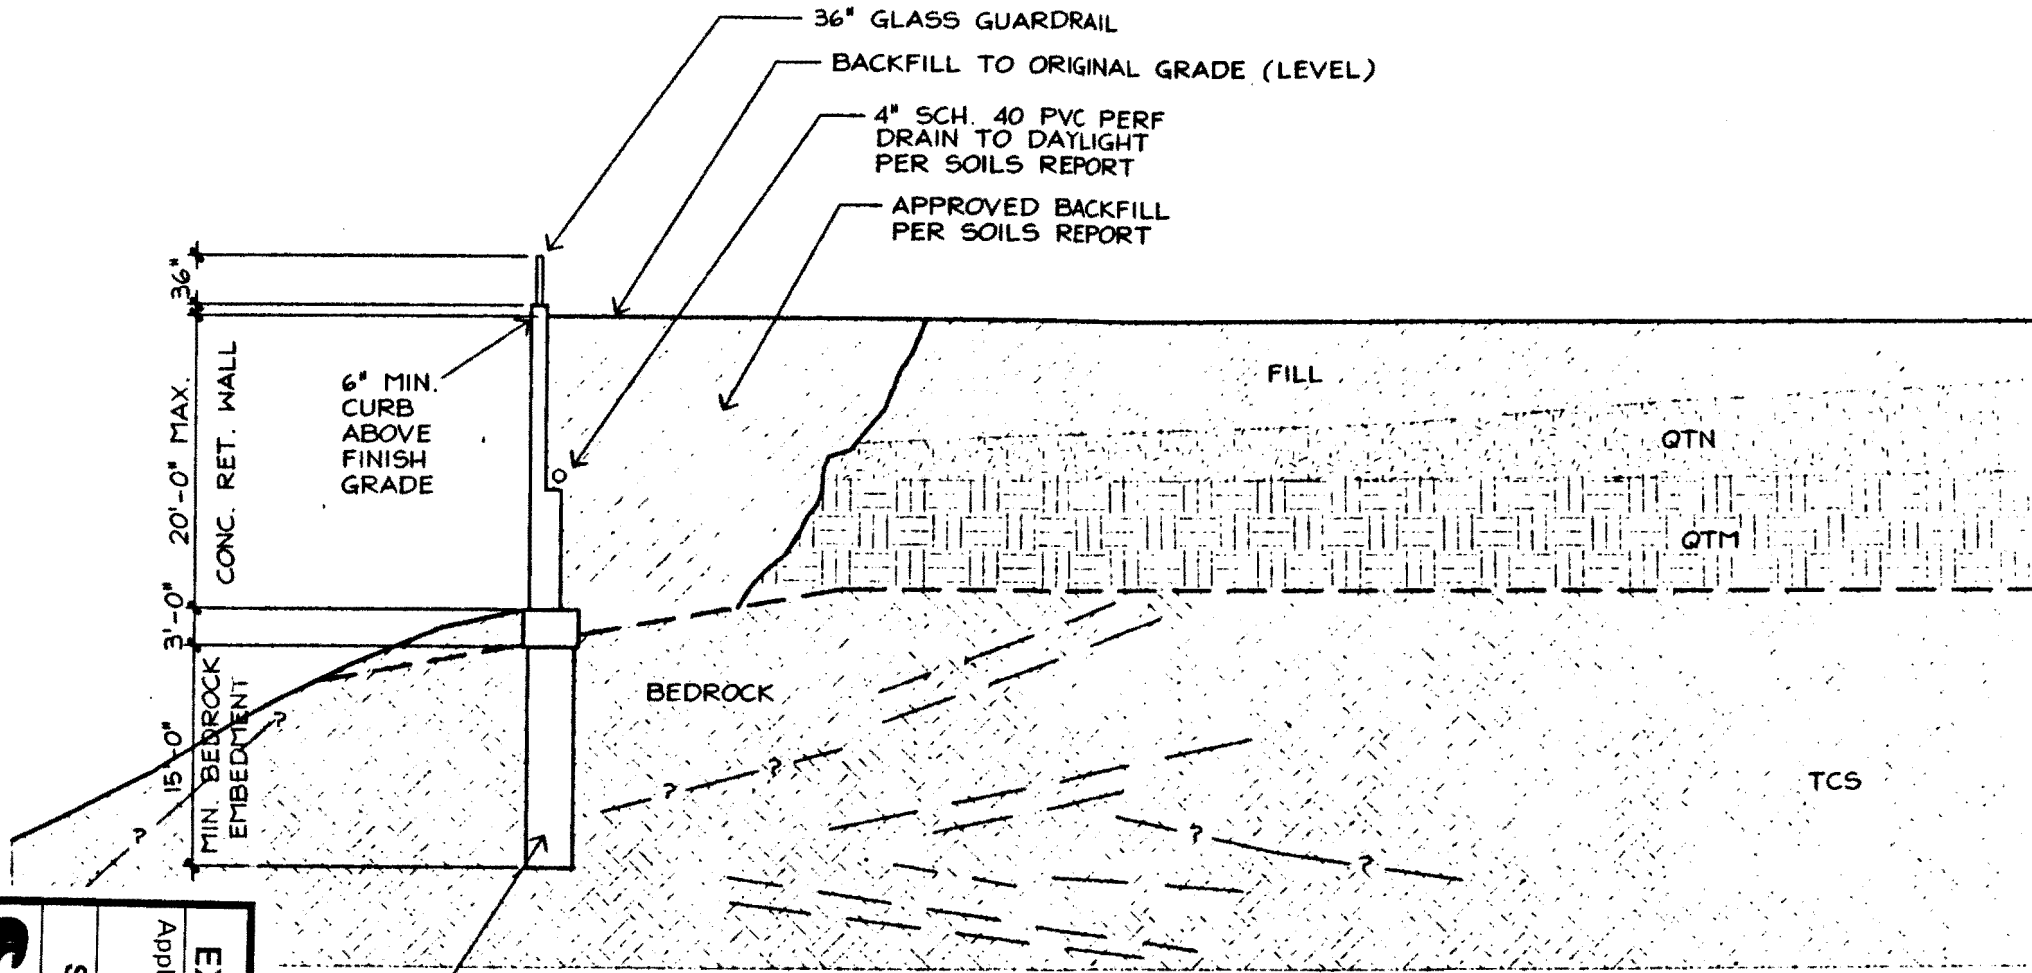
36"
20'-0" MAX.
3'-0"
15'-0"

CONC. RET. WALL

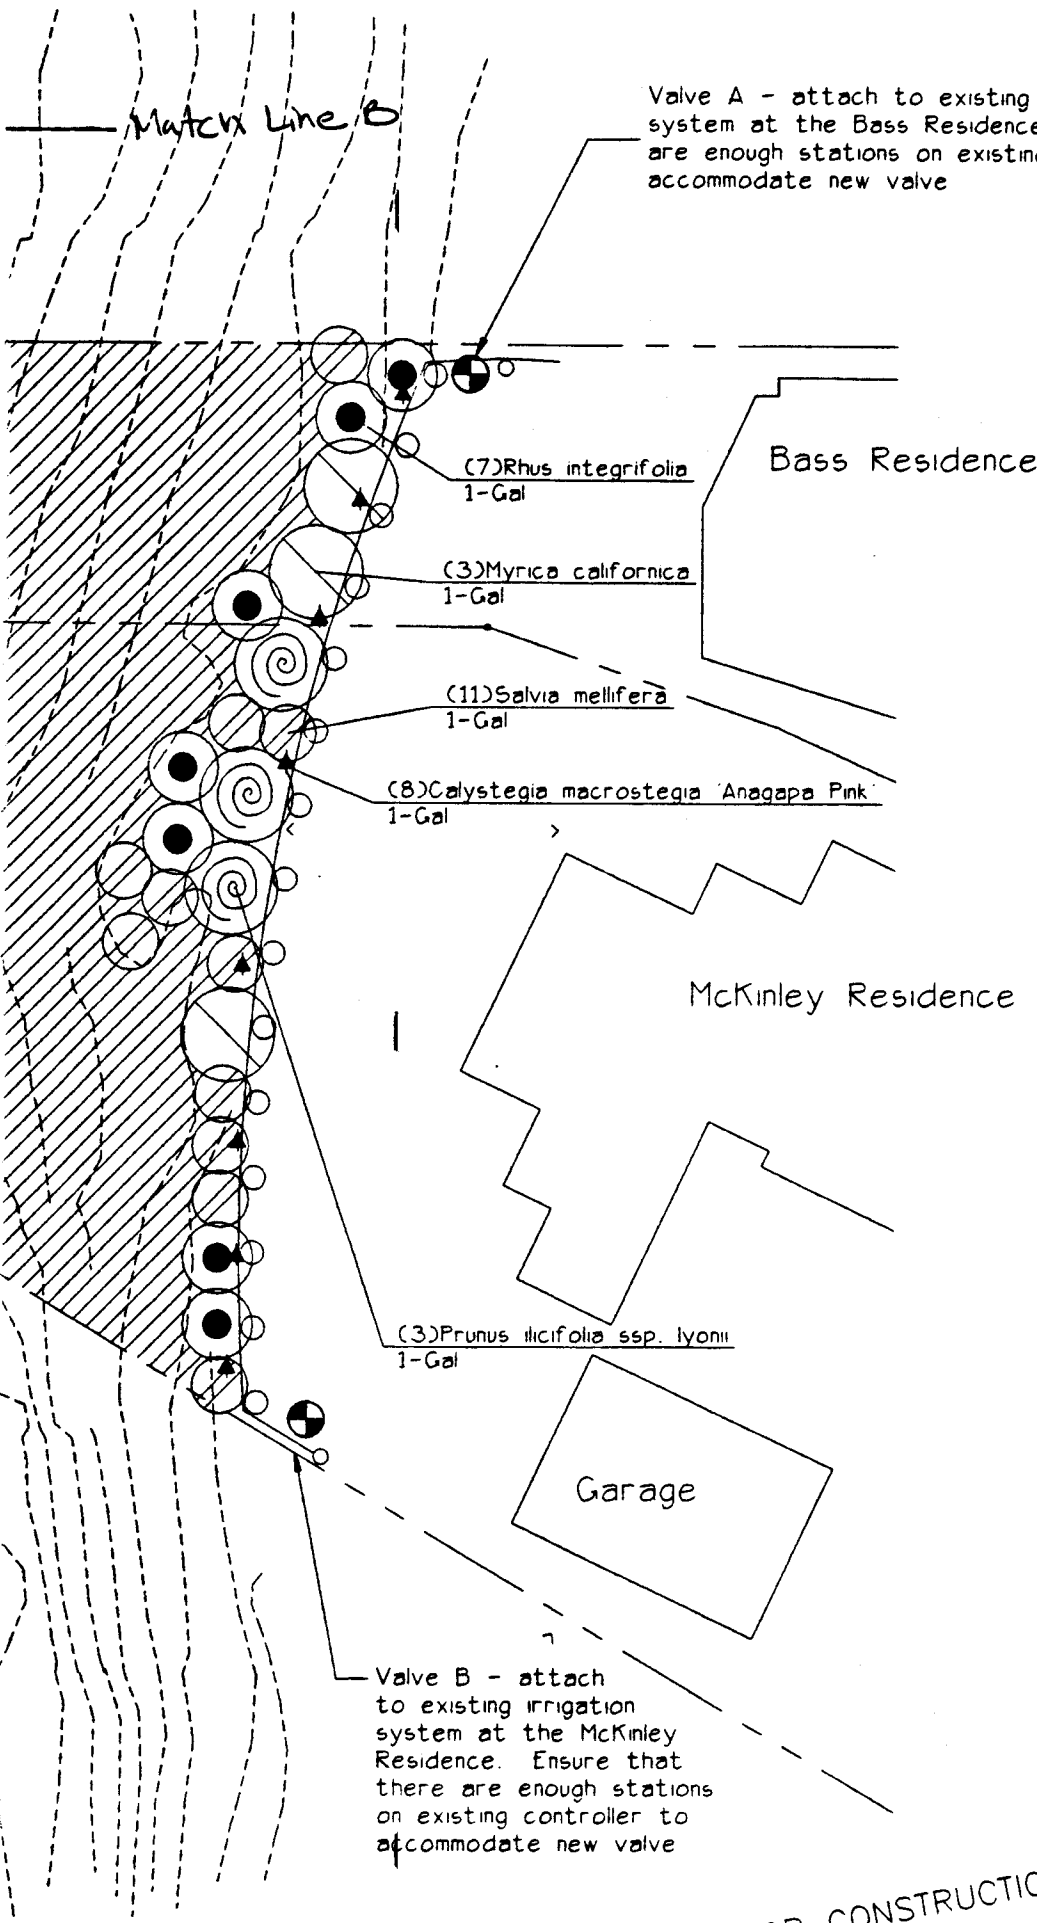
EXHIBIT No. 9
Application Number: 5-00-034
Landscaping Plan
  California Coastal Commission

Valve A - attach to existing irrigation system at the Bass Residence. Ensure that there are enough stations on existing controller to accommodate new valve

Contractor shall install all drip irrigation equipment per Manufacturer Recommended installation instructions and in compliance with Local, Municipal and State Codes.

Install EM-12 Vibra Clean Emmitter Mead below ground unless it is determined that there is not enough room or the soil will become less stable due to the extra digging. The goal is to keep animals from chewing on the equipment causing the system to dysfunction and cause possible erosion.

The Commission's coastal engineer (Exhibit 15) has reviewed the irrigation plan and found that it does not provide site-specific information nor will it provide any site specific feedback between evapotranspiration and irrigation water applied. While the Commission has approved irrigation plans for areas with an identified potential for landslides, such as at the Ocean Trails Golf Course and Pepperdine University, these plans have incorporated moisture sensors and feedback mechanisms that are continuously monitored by computer and insure that the irrigation volumes carefully match evapotranspiration rates and soil saturation. The only feedback mechanism proposed for this property is *"during periods of intense or prolonged rainfall, irrigation should be curtailed until the vegetation begins to show signs of distress."*

The Commission's coastal engineer concluded that the soil cap which is near the surface should prevent percolation of surface water into the backfill material. The current plan to provide general site irrigation of 32.6 inches annually could over-irrigate the site whenever the yearly rainfall exceeds 11.8 inches. In addition to potential saturation from irrigation, the backfill material would still be subject to potential saturation through the infiltration of groundwater traveling under the soil cap. While a detailed monitoring and irrigation plan may be beneficial in maintaining the long-term integrity of the soil cap, the proposed plan neither demonstrates that it can provide these benefits, nor demonstrates that it will not, during times of high rainfall, result in greater infiltration of the backfill material.
