CALIFORNIA COASTAL COMMISSION

STAFF REPORT: REVISED FINDINGS**APPLICATION NUMBER:** 5-00-034**RECORD PACKET COPY****APPLICANT:** Mike McKinley and John Bass**AGENT:** Alan Block**PROJECT LOCATION:** 327 and 327½ Paseo de Cristobal, City of San Clemente, Orange County

PROJECT DESCRIPTION: To permanently authorize the construction allowed under Emergency Permit 5-98-273-G for a new 110 foot long by twenty foot tall retaining wall with sixteen caissons on a coastal bluff and backfilling the area between the retaining wall and the landslide scarp with approximately 1600 cubic yards of material on two lots totaling 26,481 square feet. Re-landscaping the bluff below the retaining wall with native vegetation and the construction of new backyard hardscape on both lots.

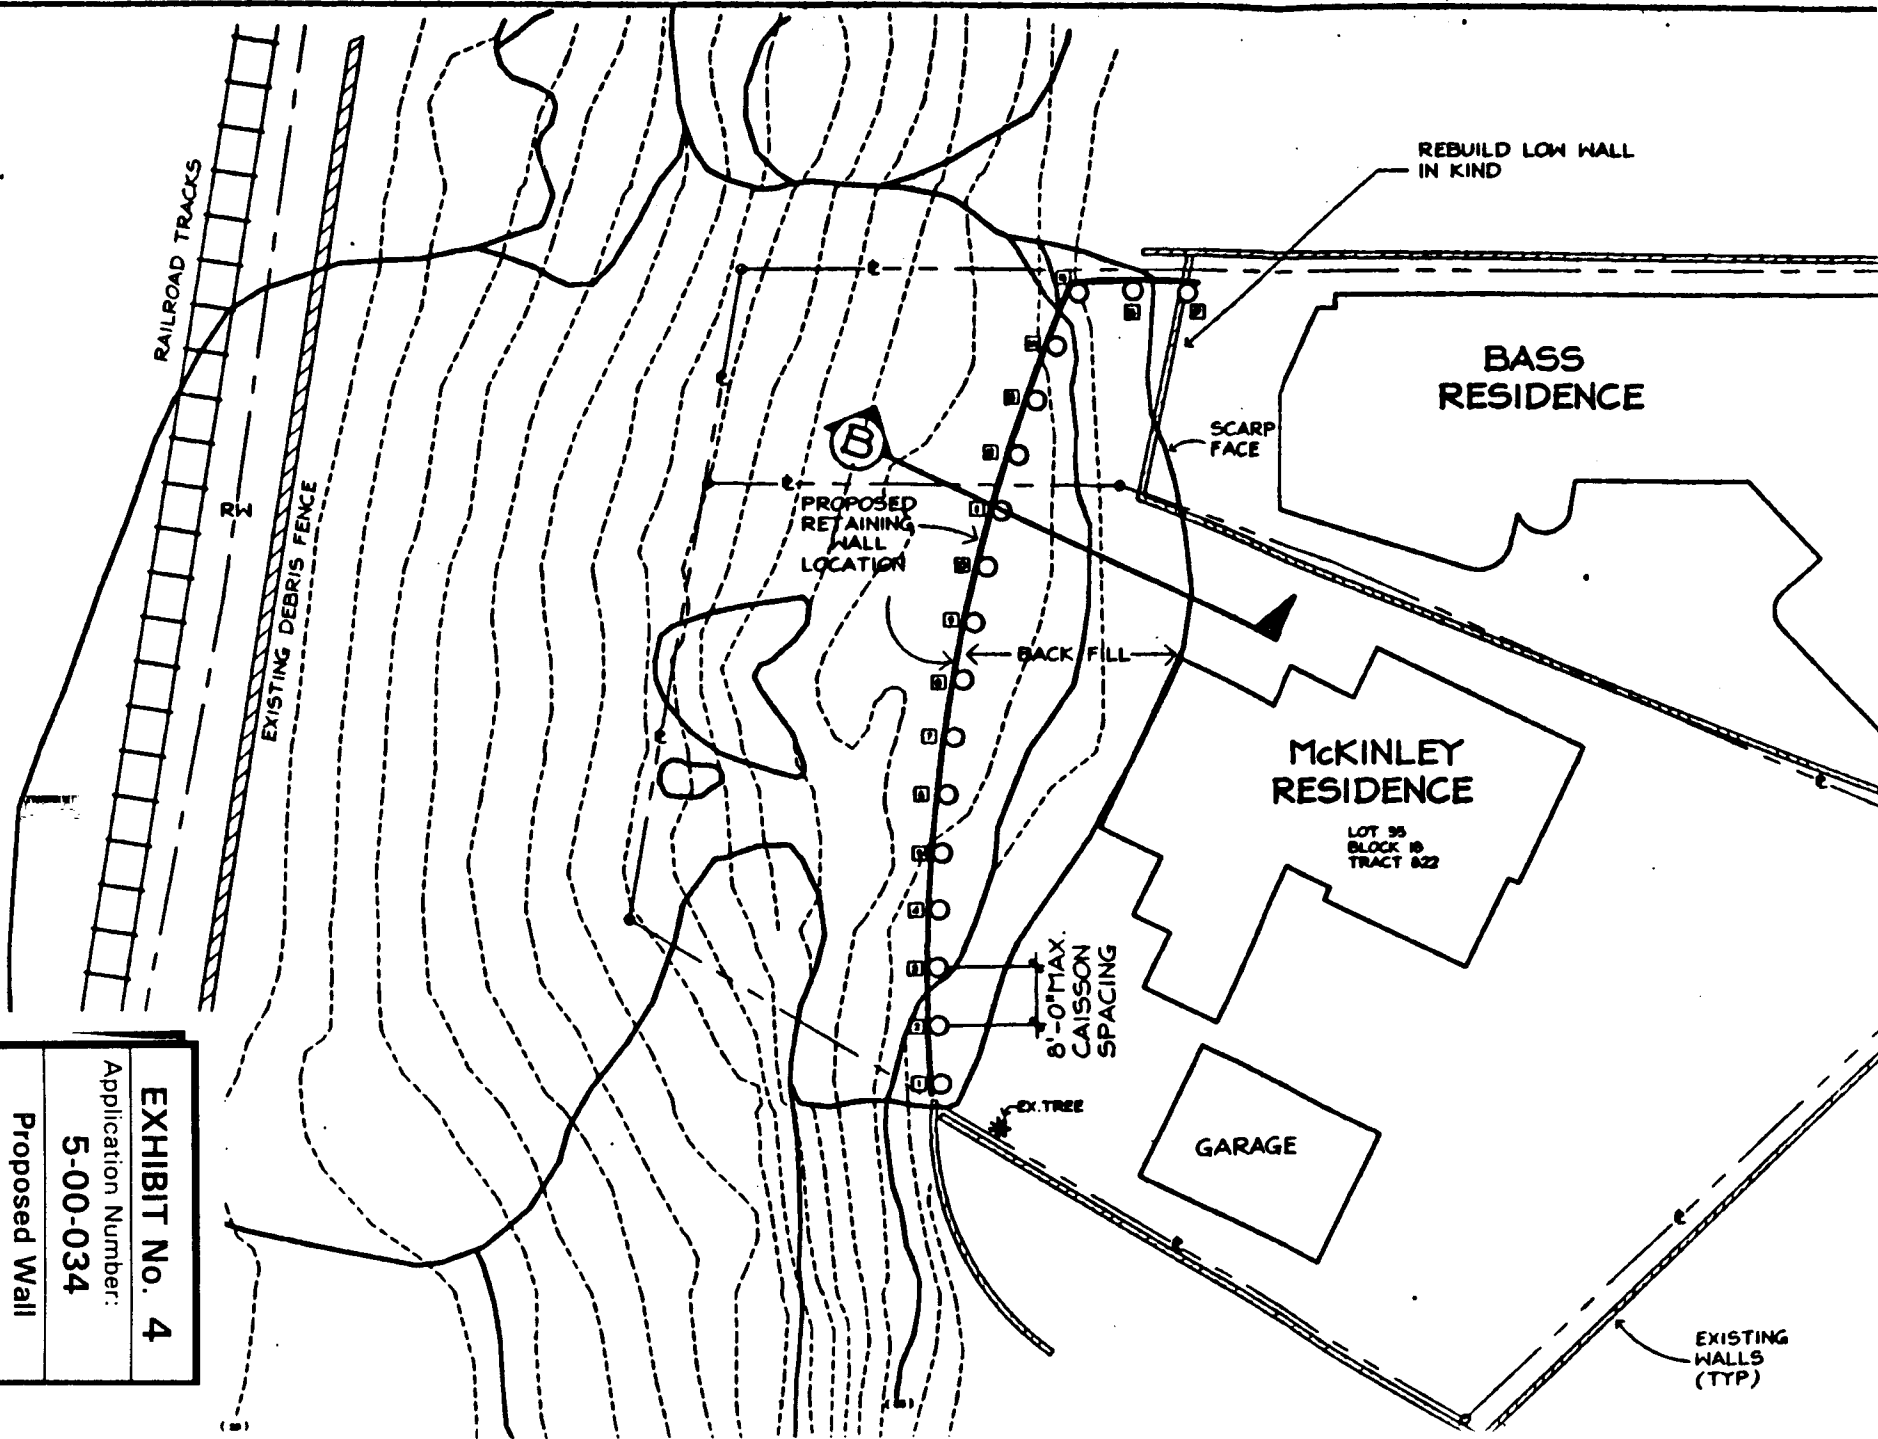
VIEW NORTHWEST
N53°E

EXPLANATION

- MATERIAL TO BE REMOVED
TO COMPETENT MATERIAL
- REPLACEMENT FILL MATERIAL
(CROSS HATCH ARE A TO BE REMOVED
PRIOR TO REPLACEMENT FILL)
- CONCRETE CASSON/BOLDER PILE

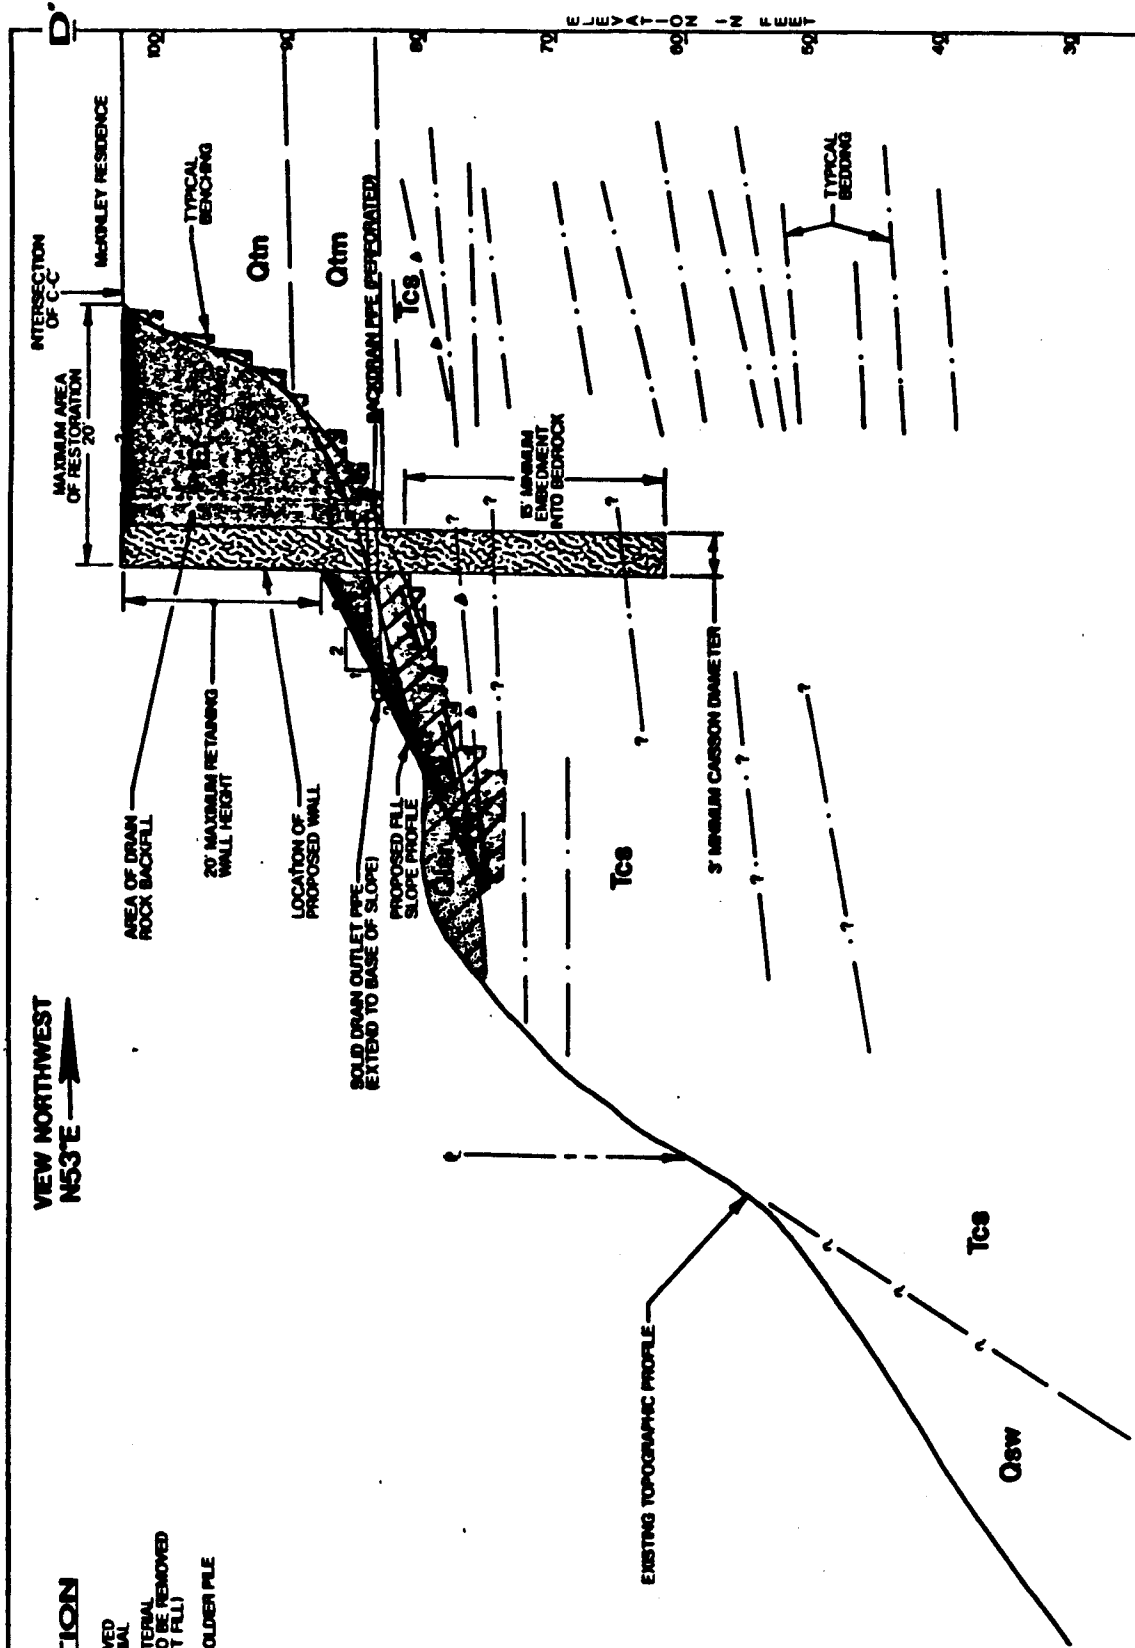
SMC	REPAIR CROSS SECTION D-D'	
	327 & 327 1/2 PASEO DE CRISTOBAL SAN CLEMENTE, CALIFORNIA	
JOB NO.: 11575-00	DATE: MAY 1998	FIGURE NO.: 2

HORIZONTAL AND VERTICAL
SCALE: 1 INCH = 10 FEET

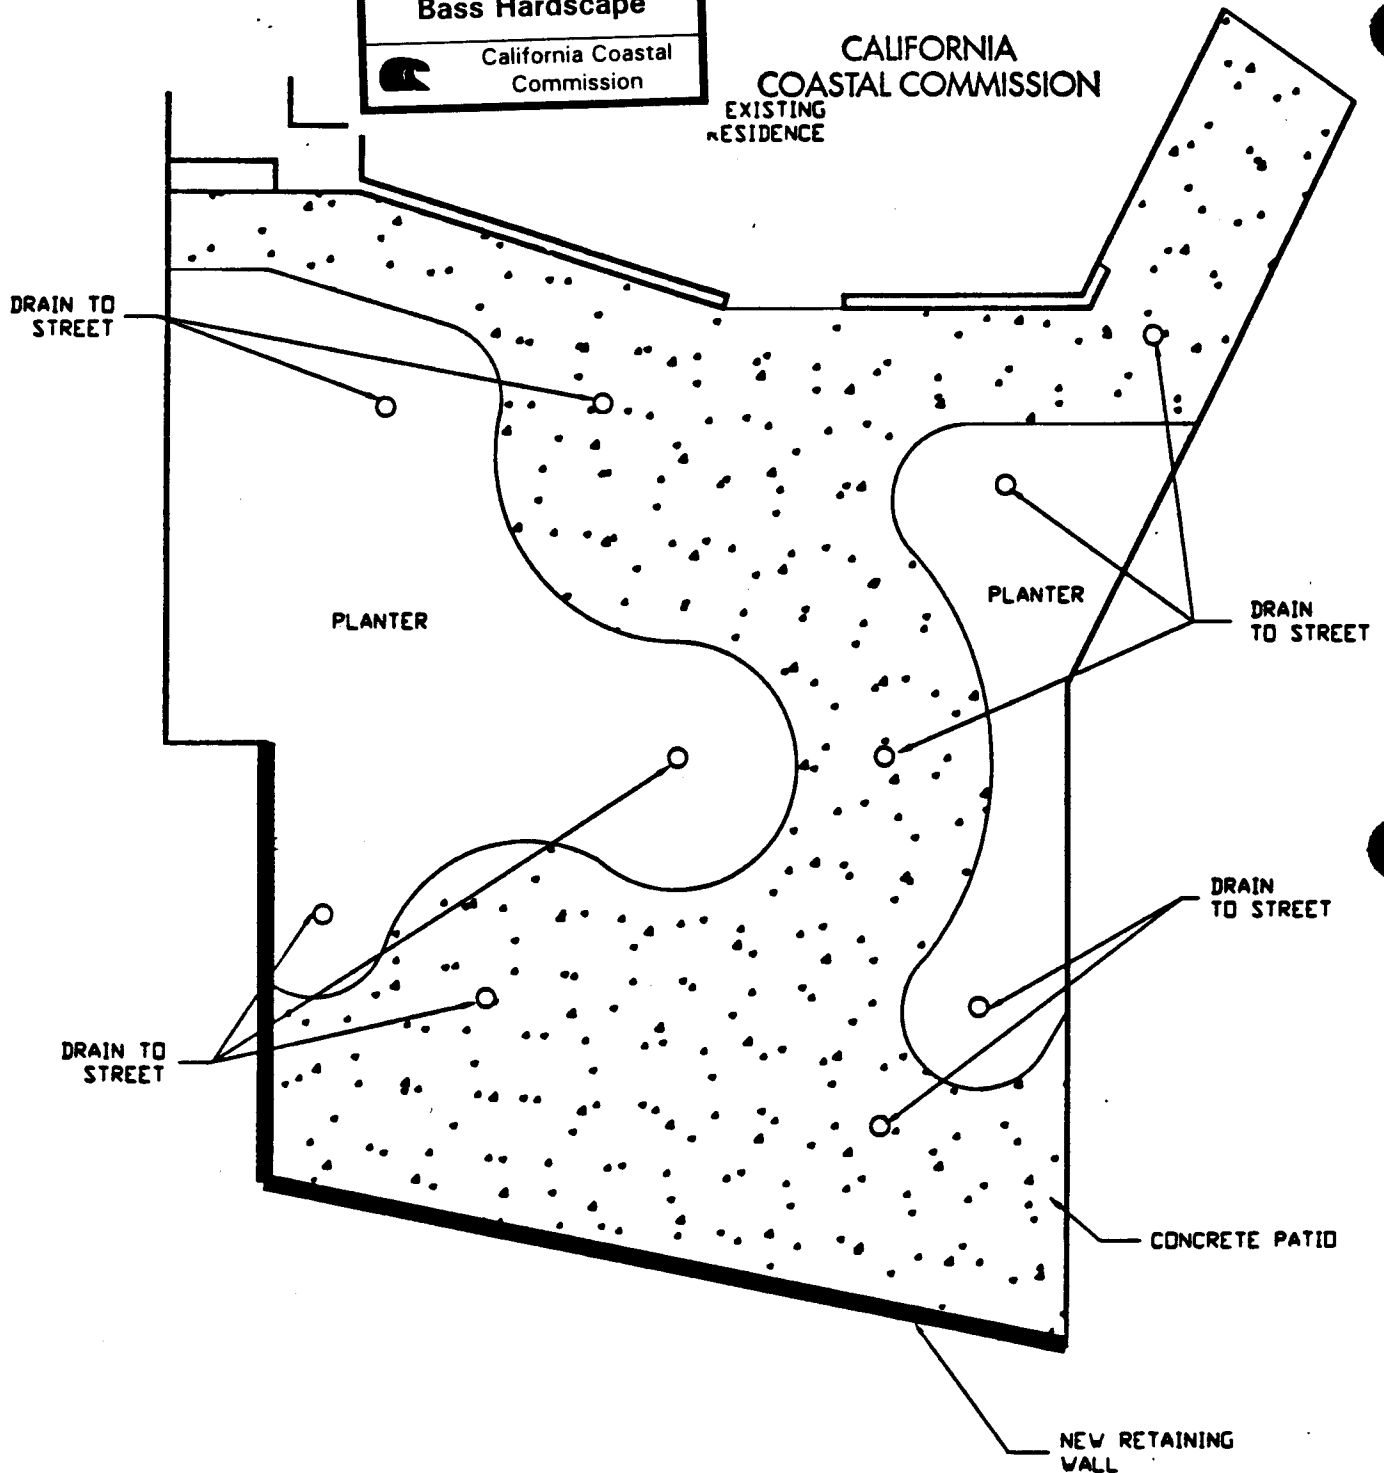
BASS RESIDENCE

ALL PLANTS TO BE DROUGHT RESISTANT,
AND NO AUTOMATIC SPRINKLERS WILL BE INSTALLED.

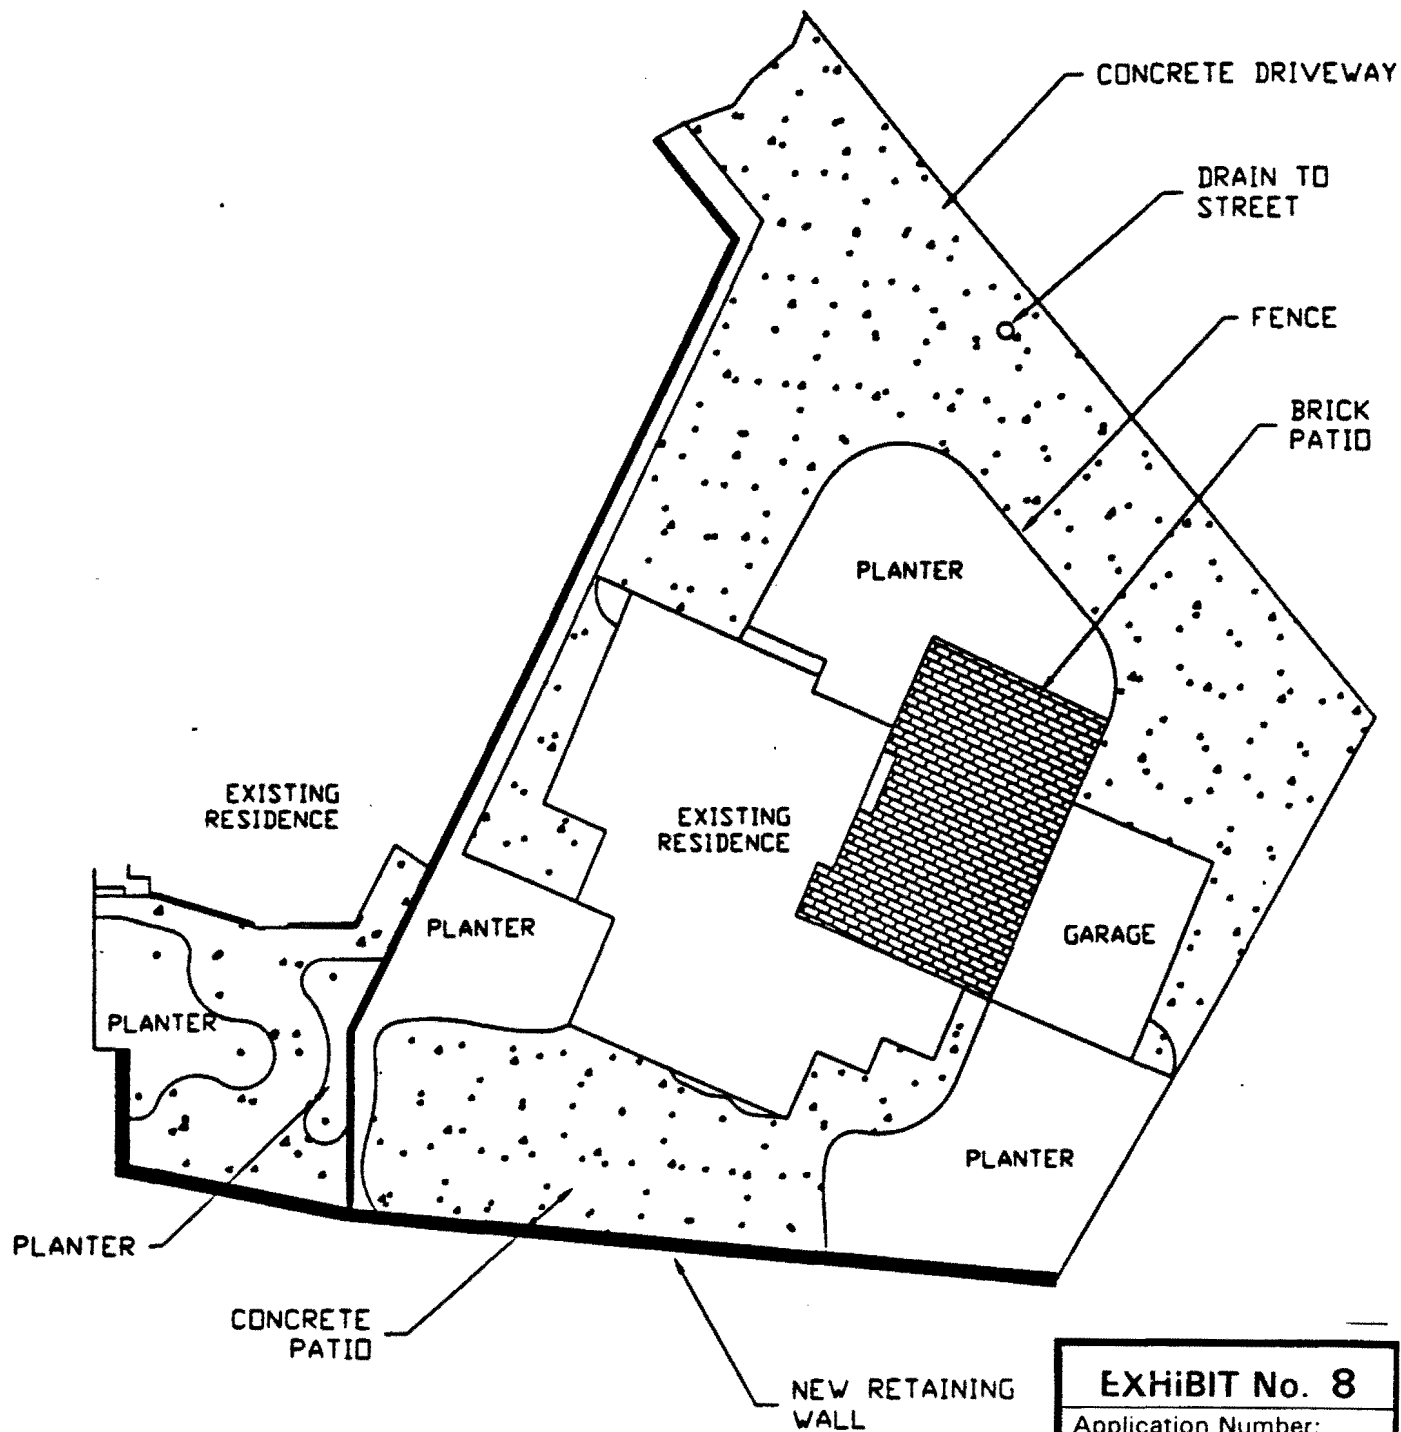
EXHIBIT No. 8

NOTE:
ALL PLANTS TO BE DROUGHT RESISTANT,
AND NO AUTOMATIC SPRINKLERS WILL BE INSTALLED.

BASS/MCKINLEY RESIDENCES

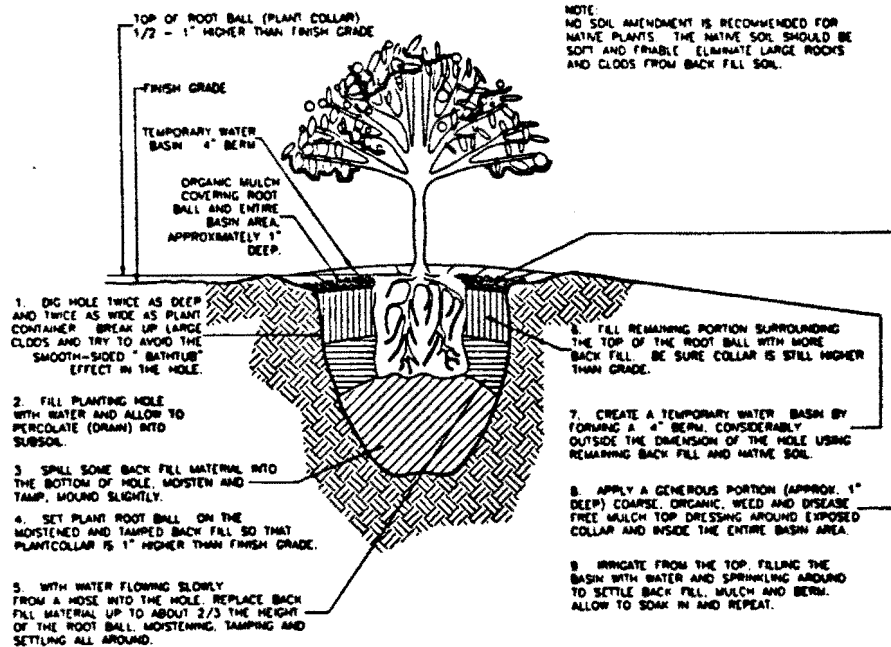
DETAIL: TREE AND SHRUB PLANTING
