COASTAL DEVELOPMENT PERMIT APPLICATION

- Application number**3-06-033, Pebble Beach Golf Links, 5th Green Seawall
- Applicant**.....Pebble Beach Company (Cheryl Burrell)
- Project location**Pebble Beach Golf Links 5th Hole (APN 008-403-003), Pebble Beach (Monterey County).

- Project description**Construct a seawall at base of the coastal bluff to protect the 5th Green, using concrete reinforced with steel tiebacks and artificial stone fascia. The proposed seawall is 160 feet long with 22 feet of buried wing walls (182 lineal feet total), and ranges from 6.5 to 14.5 feet tall (total of 14 to 22 feet in height including below ground portion of structure), with unprotected upper bluff backfilled and vegetated to re-create 2:1 slope.

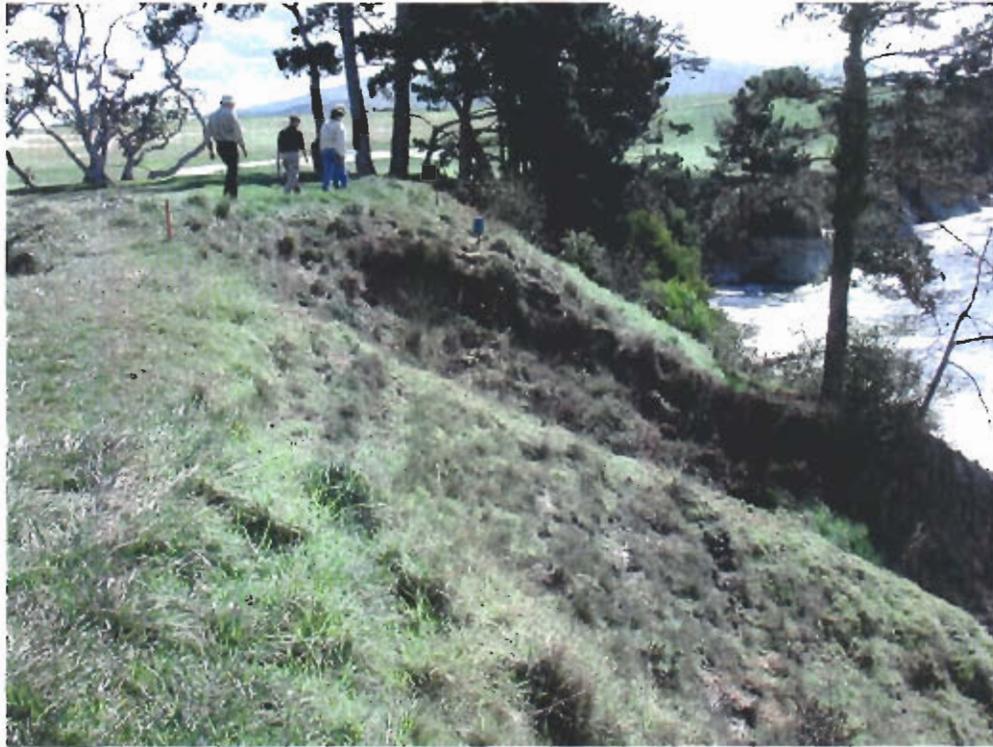
Photo 1
Staff photo of landslide scarp and erosional gully near 5th green (bunker to left)

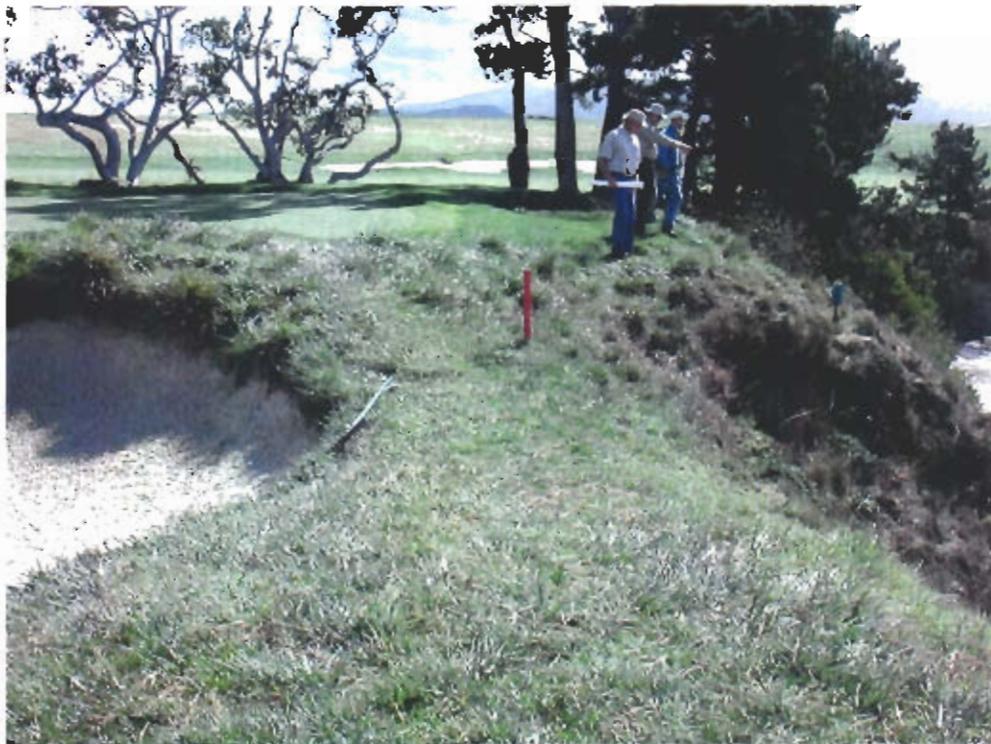
Photo 2
Staff photo of proximity of sand trap and 5th green to top of landslide scarp

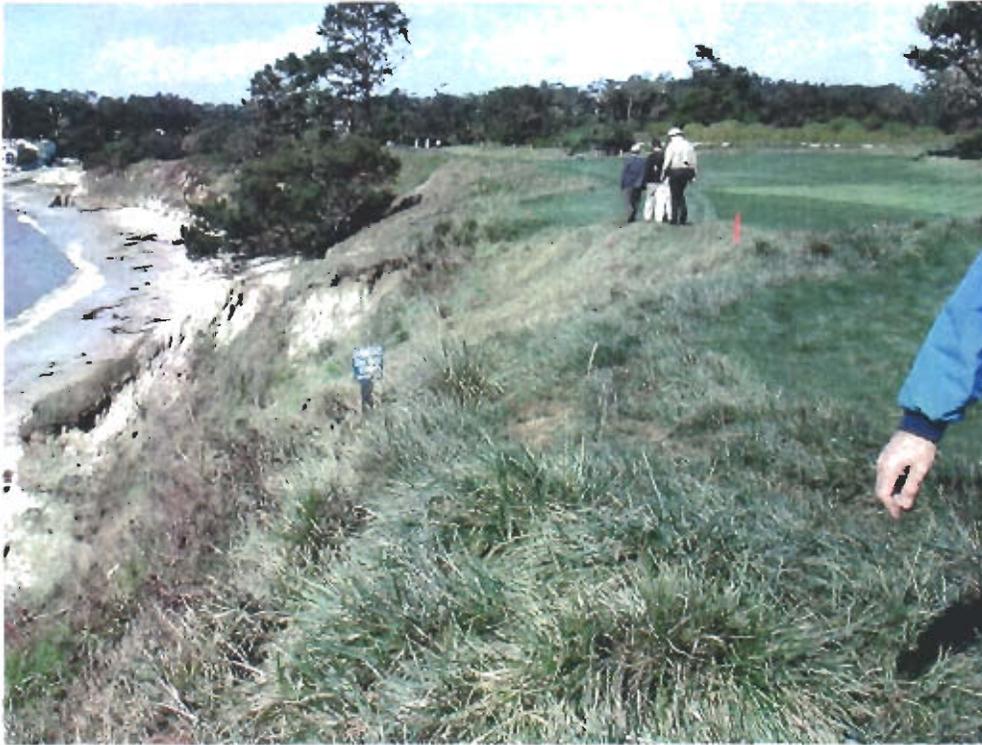
Photo 3
Staff photo looking north from 5th green, showing proximity of hole to top of bluff

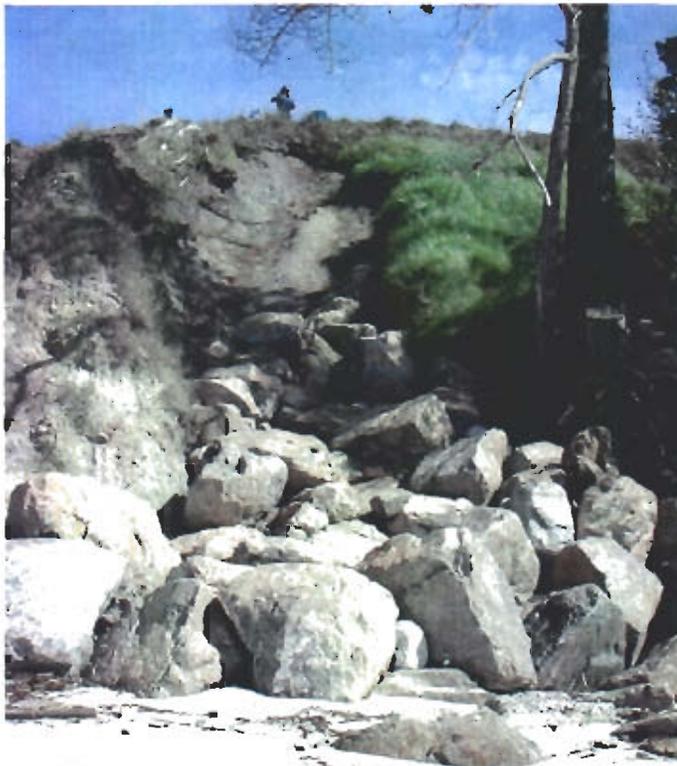
Photo 4
Staff photo of emergency revetment and shotcrete in erosional gully formed by landslide below 5th green

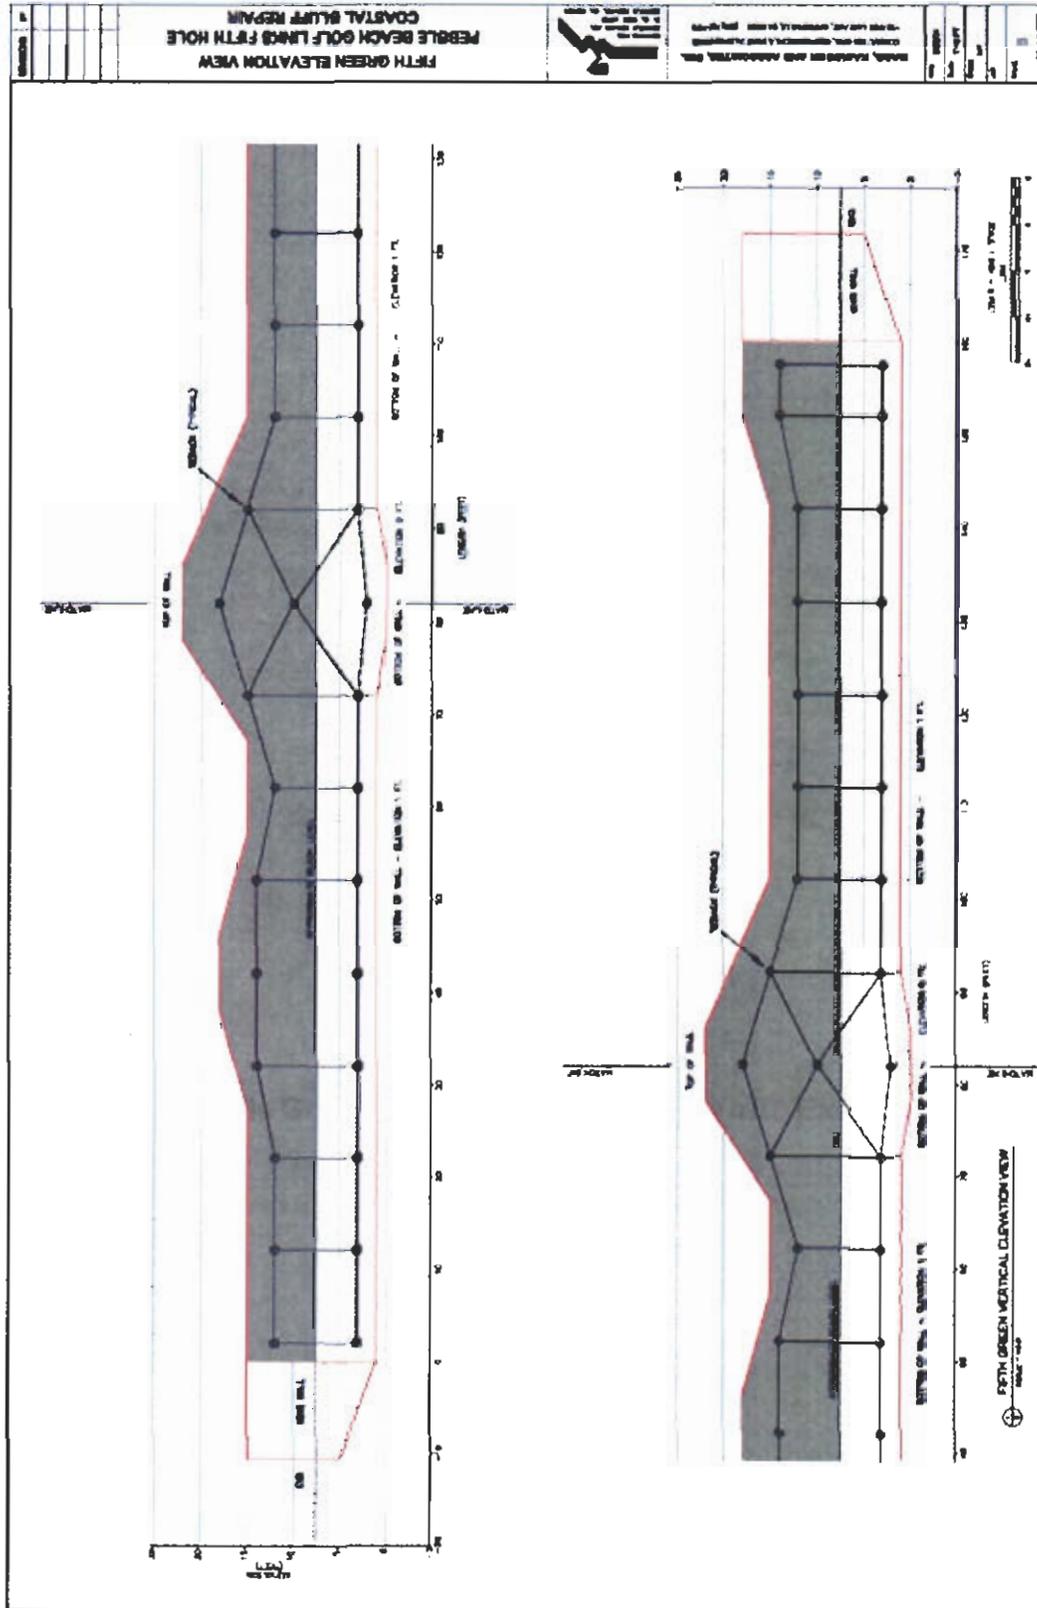
Exhibit G – page 2 of 2
 Proposed Site Plans and Elevations

Existing / *Proposed* View as seen from Beach looking North (Fifth Green)

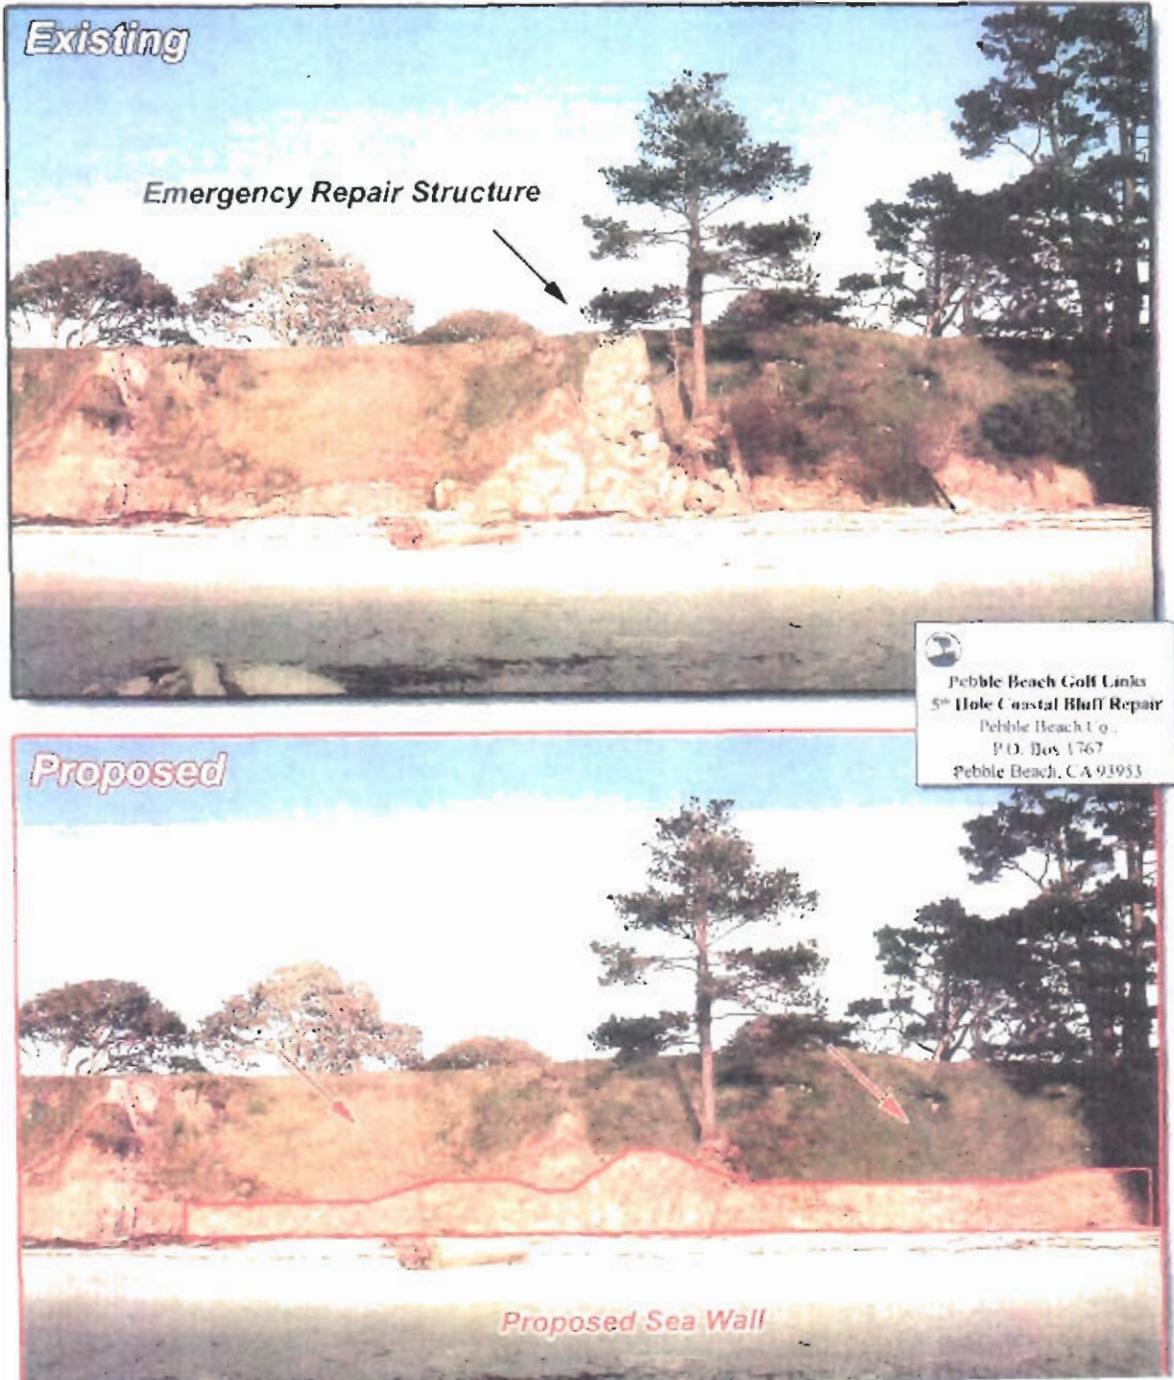
Exhibit H
Visual Simulation of Coastal Bluff Before and After Proposed Seawall

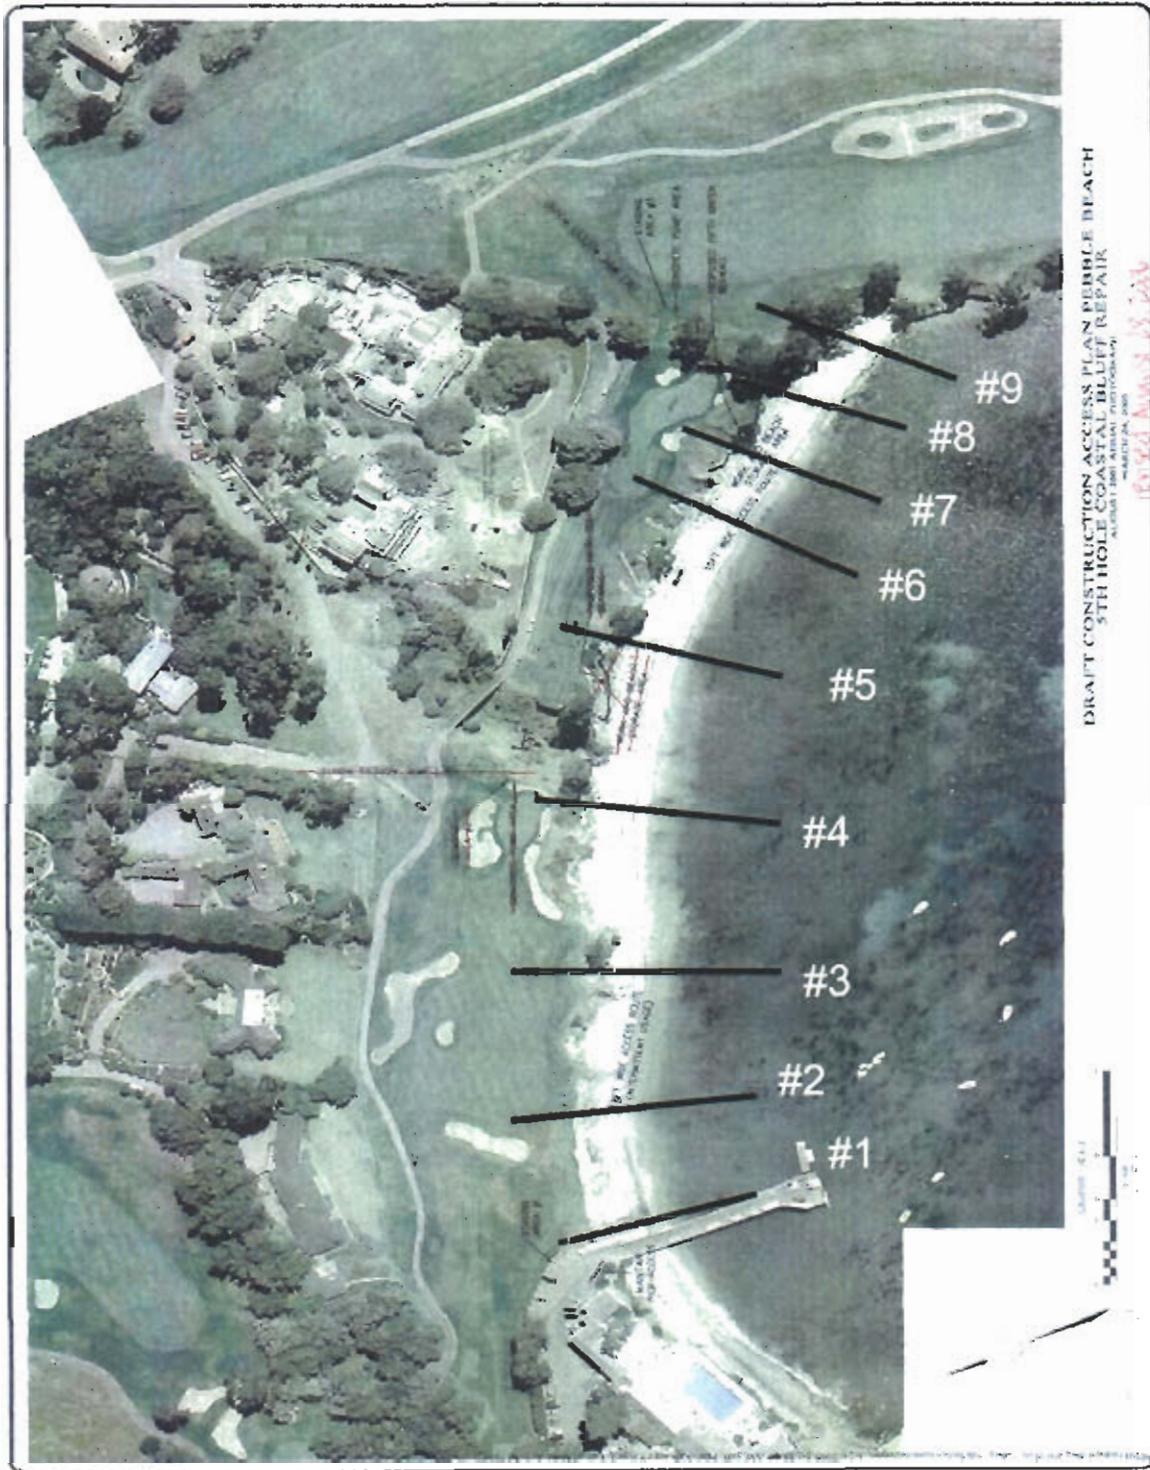
Exhibit L.2
2001 Aerial Photo of Site Showing Required Beach and Bluff Profiles -
Approximate Locations

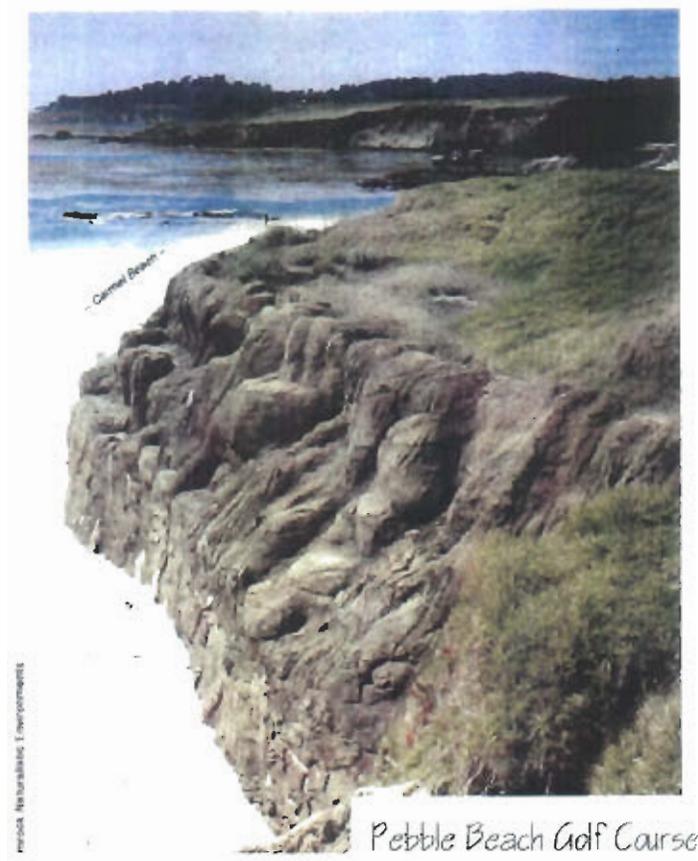
Photo 1
Applicant's photo
of 9th Hole seawall
(Summer 1998)

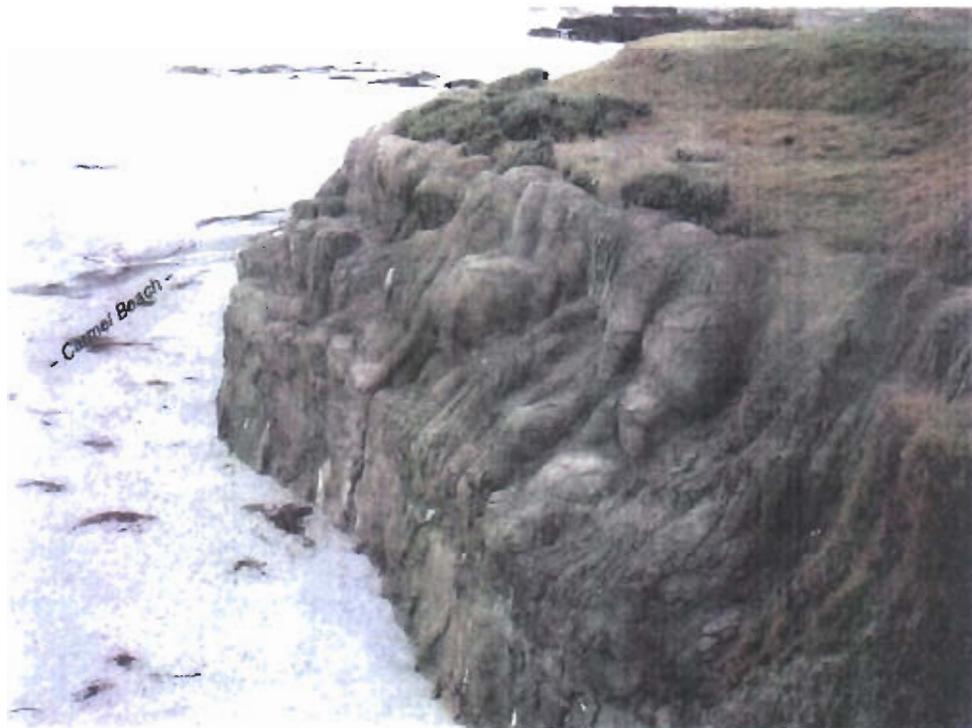
Photo 2
Applicant's photo
of 9th Hole seawall
(6/24/04)

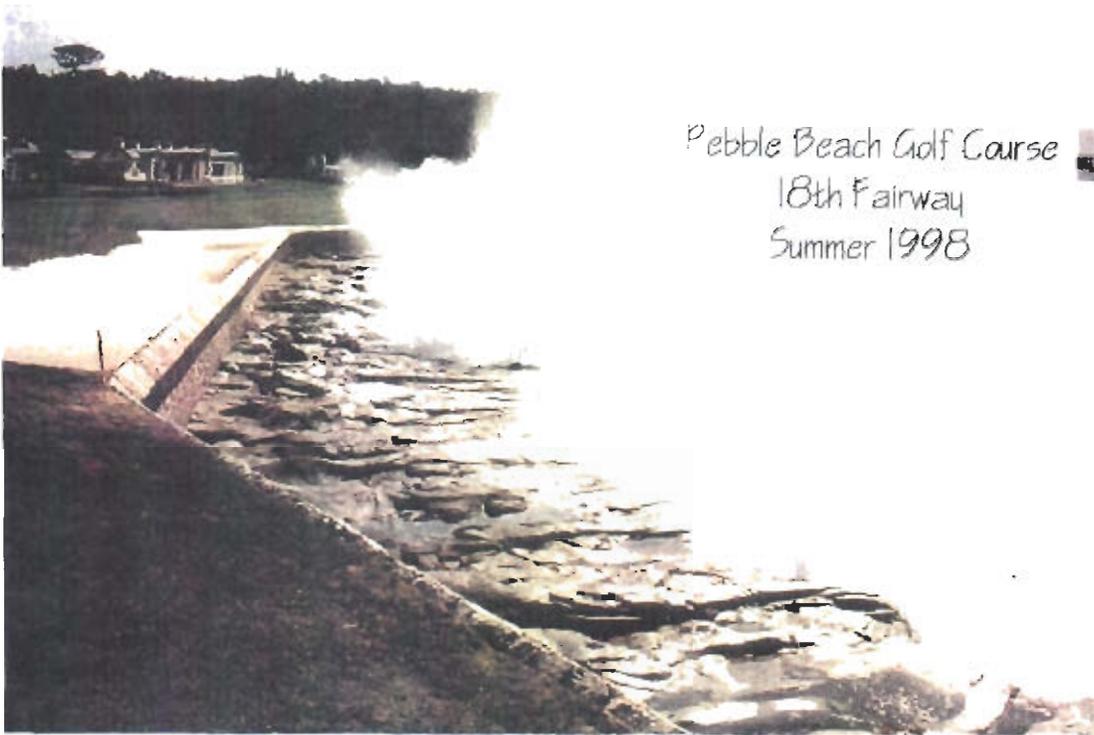
Photo 3
Applicant's photo of seawall at 18th fairway (Summer 1998)

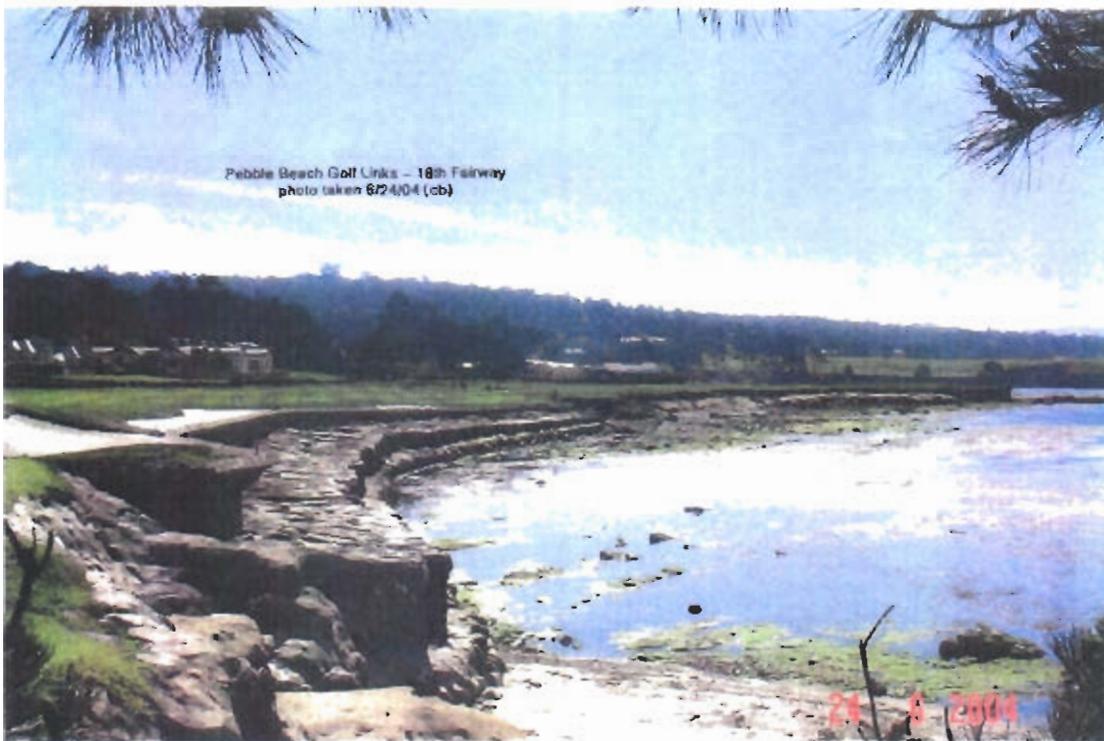
Photo 4
Applicant's photo of seawalls along 18th green (in foreground), fairway, and tee (on right side of photo) (6/25/04)

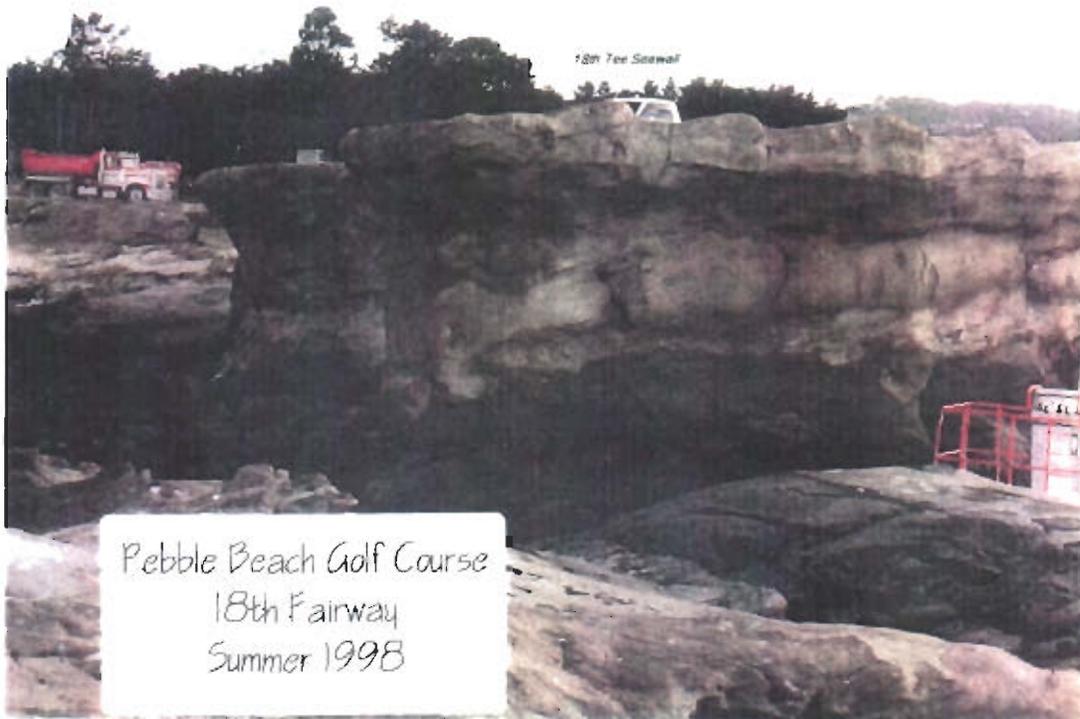
Photo 5
Applicant's photo of seawall at 18th Tee (Summer 1998)

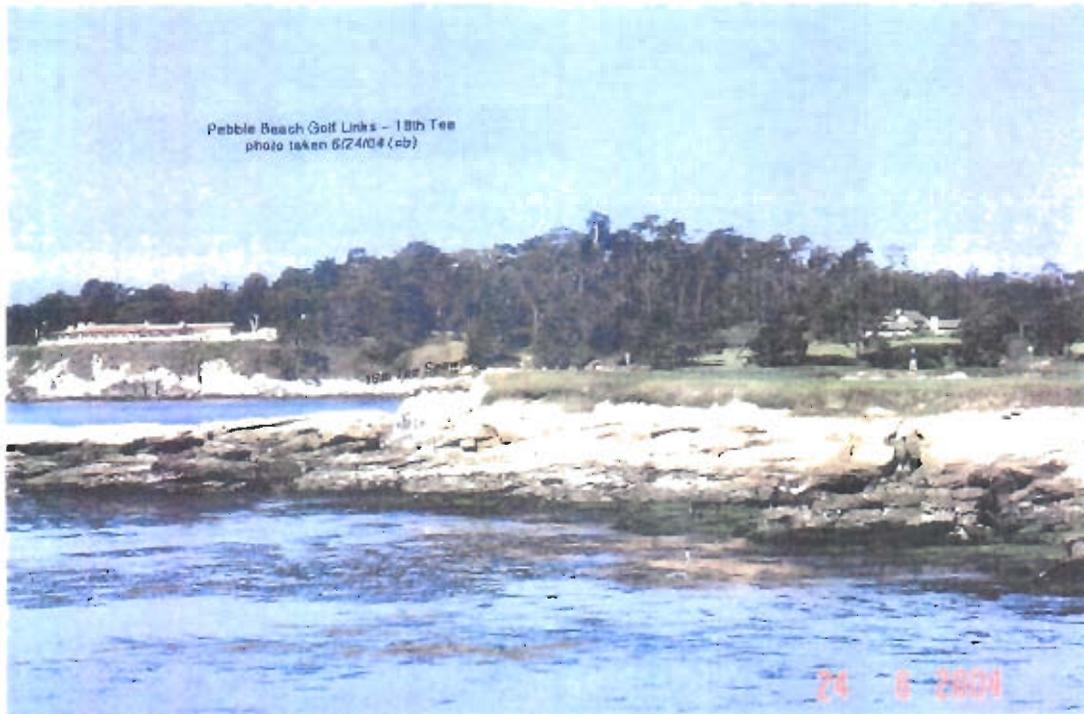
Photo 6
Applicant's photo of seawall at 18th Tee (6/24/04)

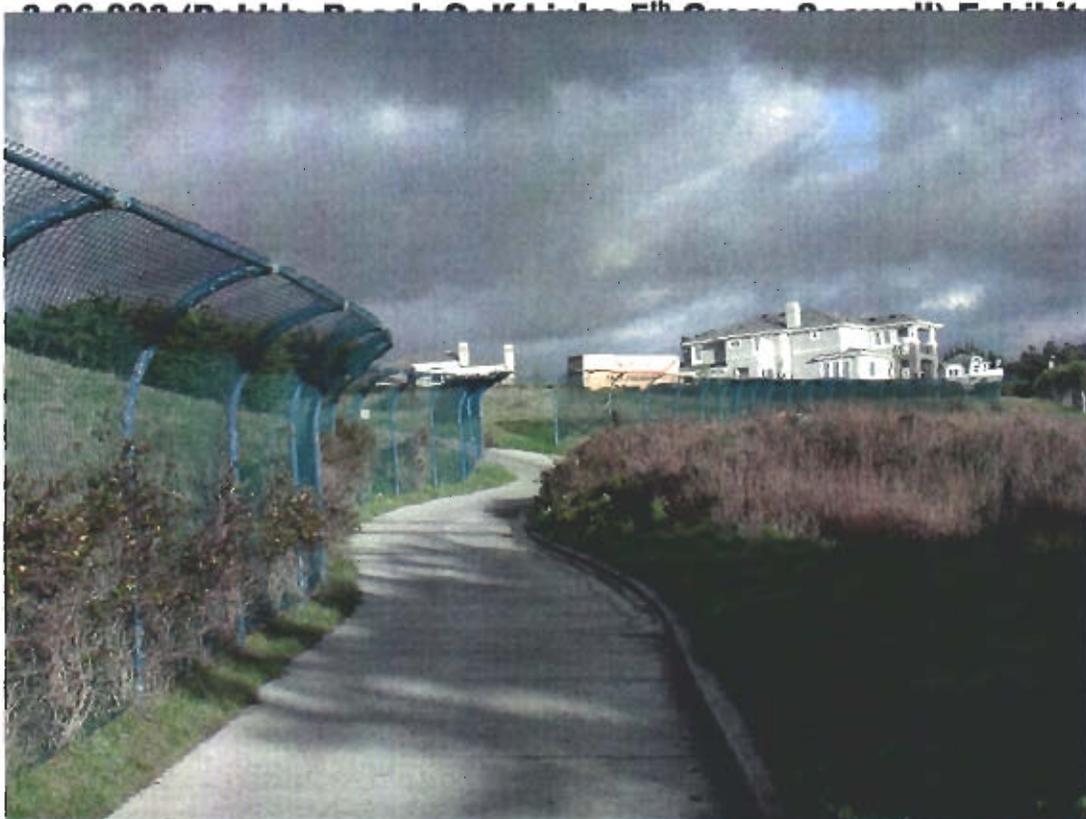
Photo 1
Staff photo of protective fencing along public accessway through Ocean Colony Golf course in Half Moon Bay (Note: grade break on the left side of photo; in time, planted vegetation will screen fencing)

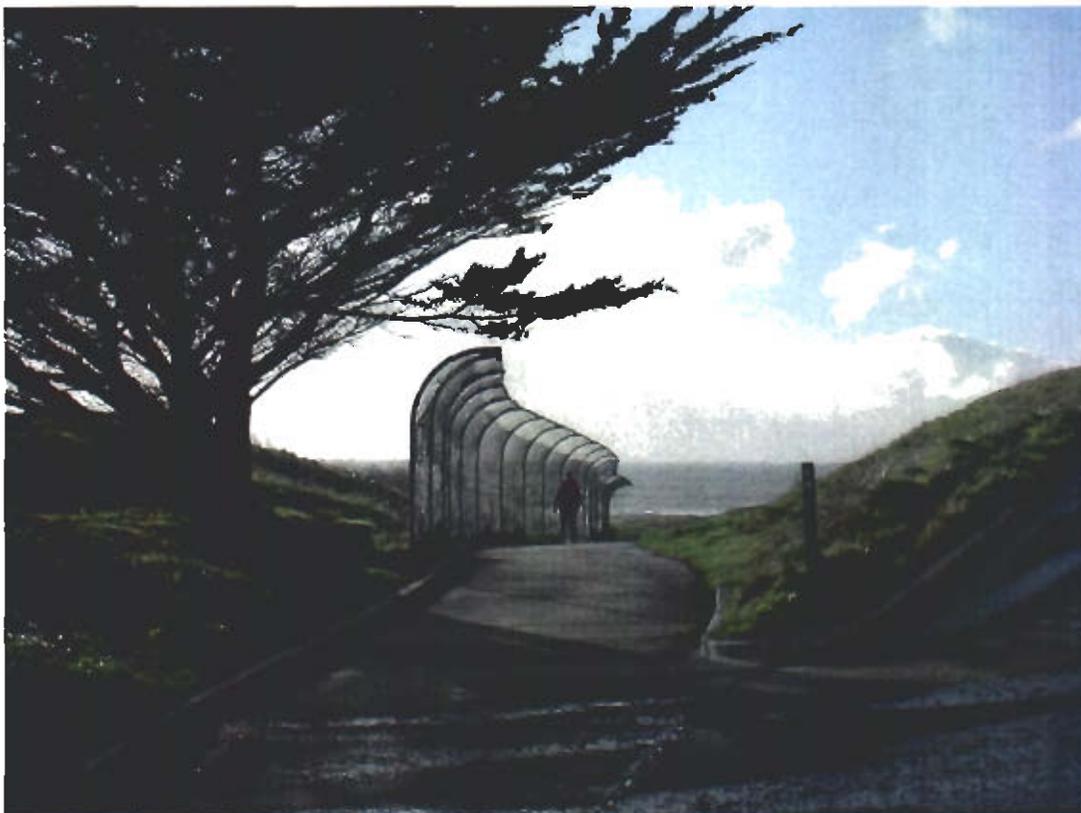
Photo 2
Staff photo of protective fencing along public accessway through Ocean Colony Golf course in Half Moon Bay (Note: direction of play is from left to right)
