## CALIFORNIA COASTAL COMMISSION

## MEMORANDUM

SUBJECT: Recommended Boundaries of CCC Wetlands at Terrace Point

DATE: August 10, 2007

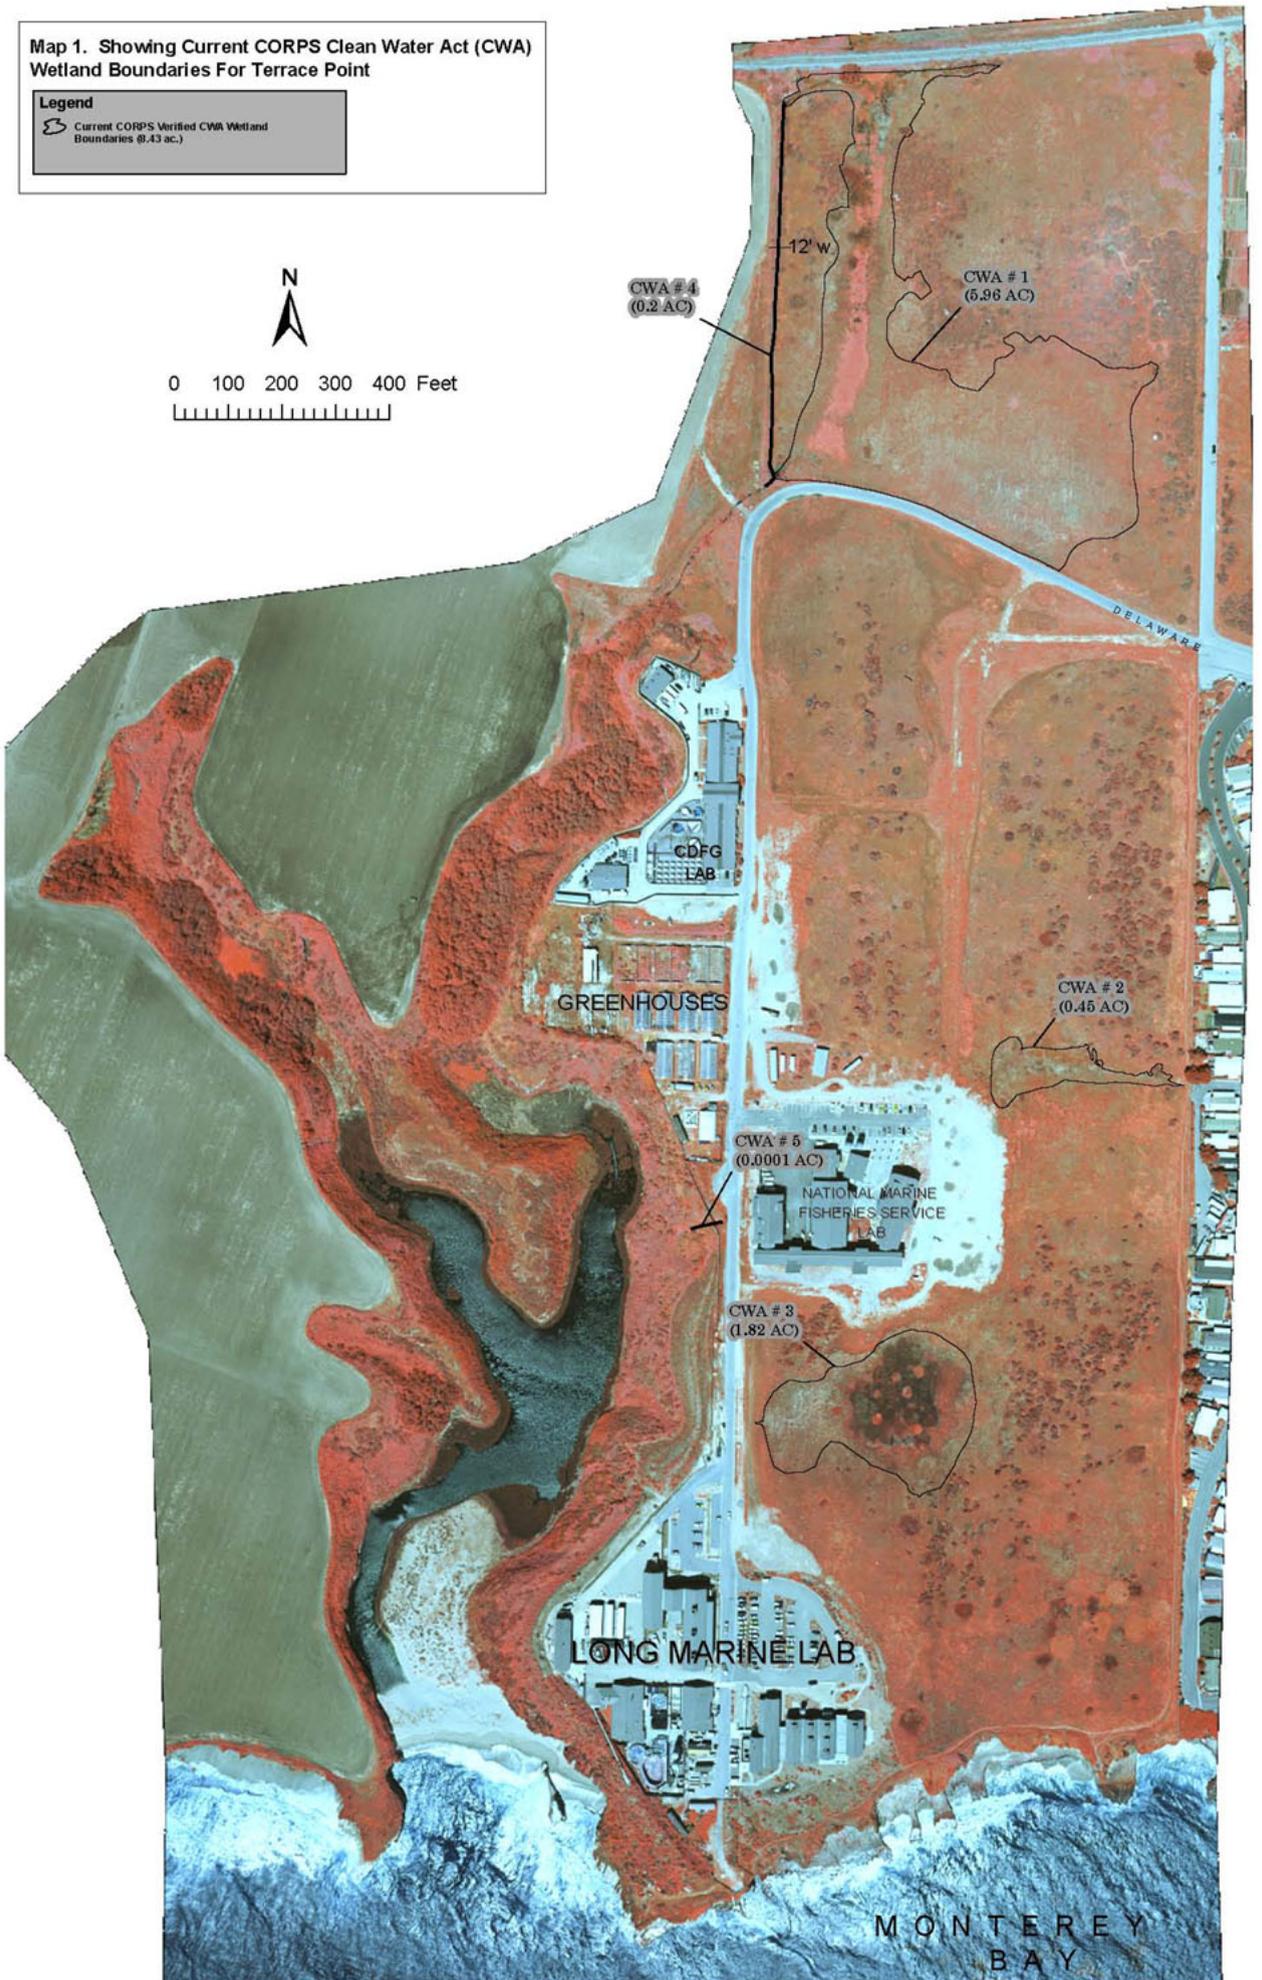
Map 1. Showing Current CORPS Clean Water Act (CWA) Wetland Boundaries For Terrace Point

Current CORPS Verified CWA Wetland Boundaries (8.43 ac.)

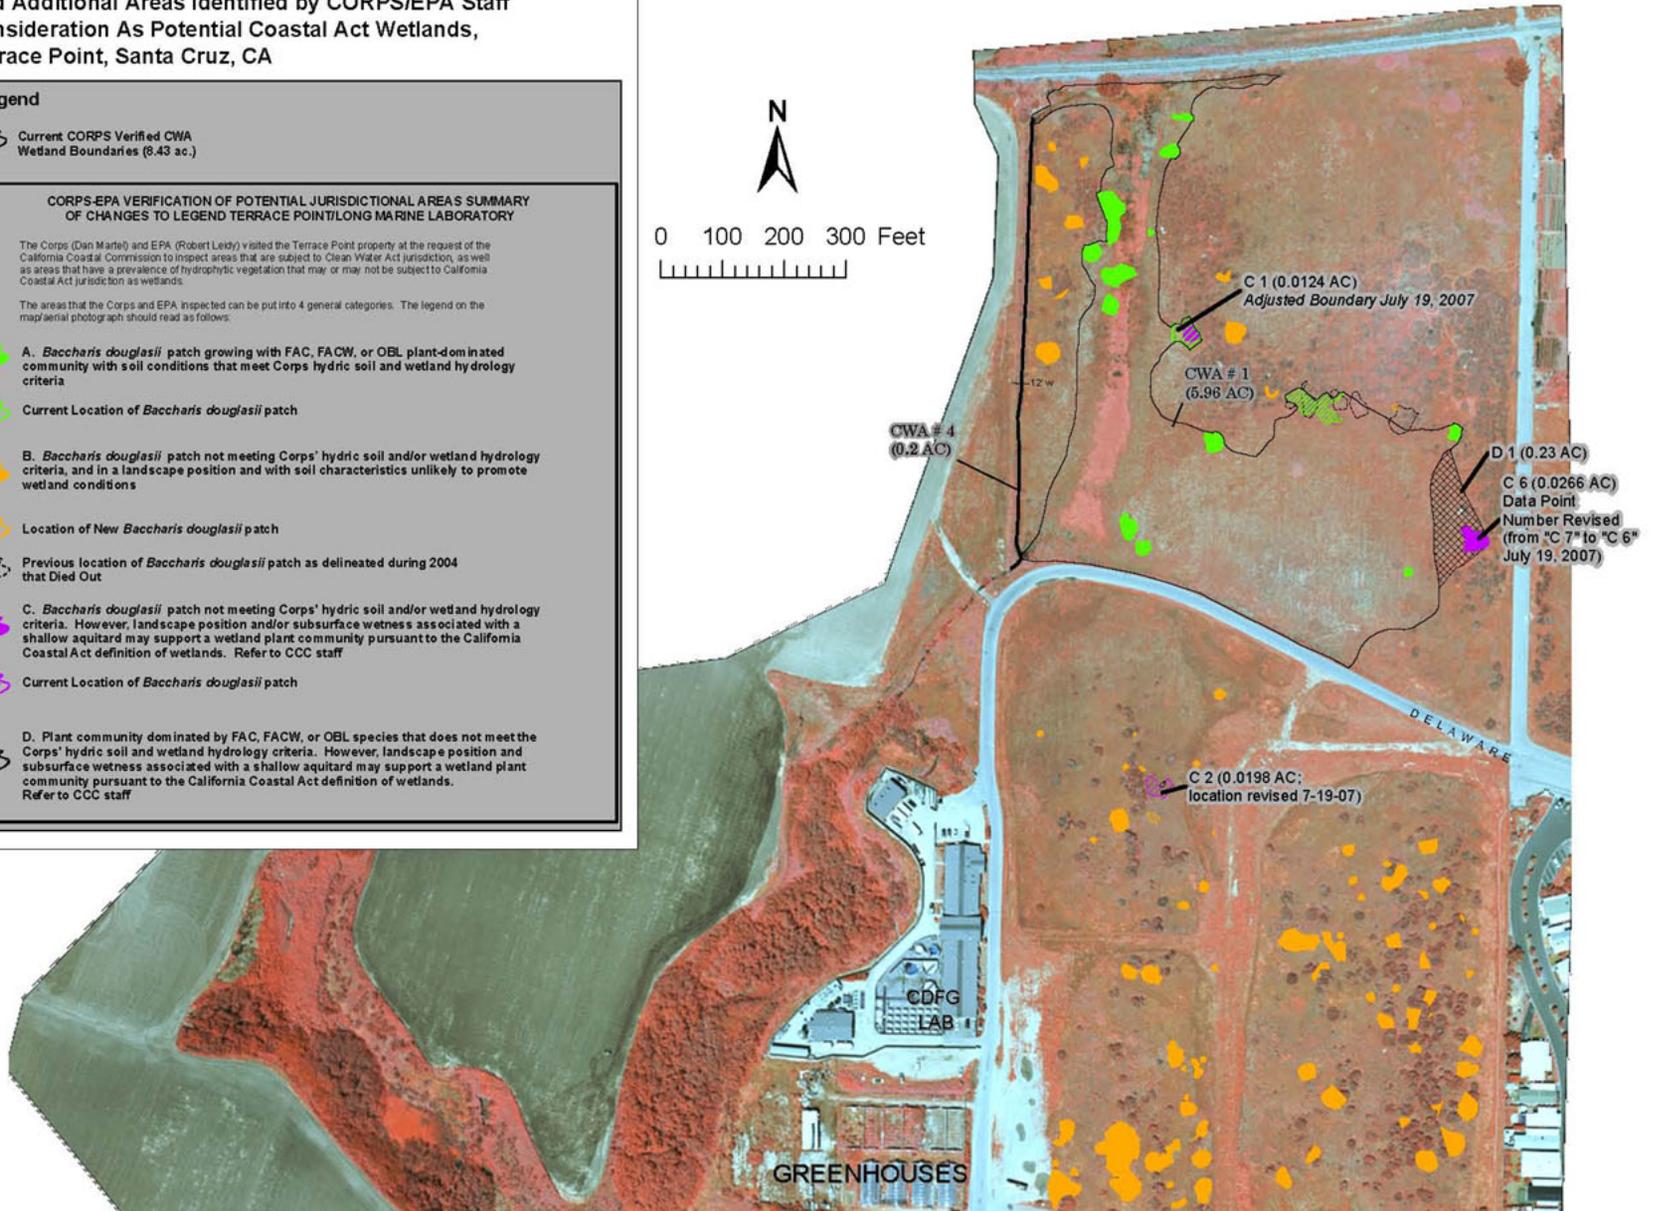
**Map 2A. Current CORPS Verified CWA Wetland Boundaries, And Additional Areas Identified by CORPS/EPA Staff Consideration As Potential Coastal Act Wetlands, Terrace Point, Santa Cruz, CA**

The Corps (Dan Martel) and EPA (Robert Leiby) visited the Terrace Point property at the request of the California Coastal Commission to inspect areas that are subject to Clean Water Act jurisdiction, as well as areas that have a prevalence of hydrophytic vegetation that may or may not be subject to California Coastal Act jurisdiction as wetlands.

The areas that the Corps and EPA inspected can be put into 4 general categories. The legend on the map/aerial photograph should read as follows:

In my April 25, 2007 memorandum addressed to you, I described the independent wetland assessment that was provided to the Coastal Commission by Mr. Dan Martel of the Army Corps of Engineers and Dr. Robert Leidy of the U.S. Environmental Protection Agency. Attachment 1 to Dr. Leidy's report dated April 24, 2007 shows the March 2007 federal delineation and Attachment 2 shows both the federal wetland boundary and 8 areas (6 patches of *Bacharis douglasii* (OBL) and 2 patches of *Lolium perenne* (FAC)

and other indicator species) that Mr. Martel and Dr. Leidy thought had soil and landscape characteristics that might result in sufficient subsurface wetness to be considered "wetland" under the definition in the Commission's Regulations. These independent experts considered all other areas, including those with a preponderance of wetland indicator species such as *B. douglasii* and *L. perenne*, to be "upland."

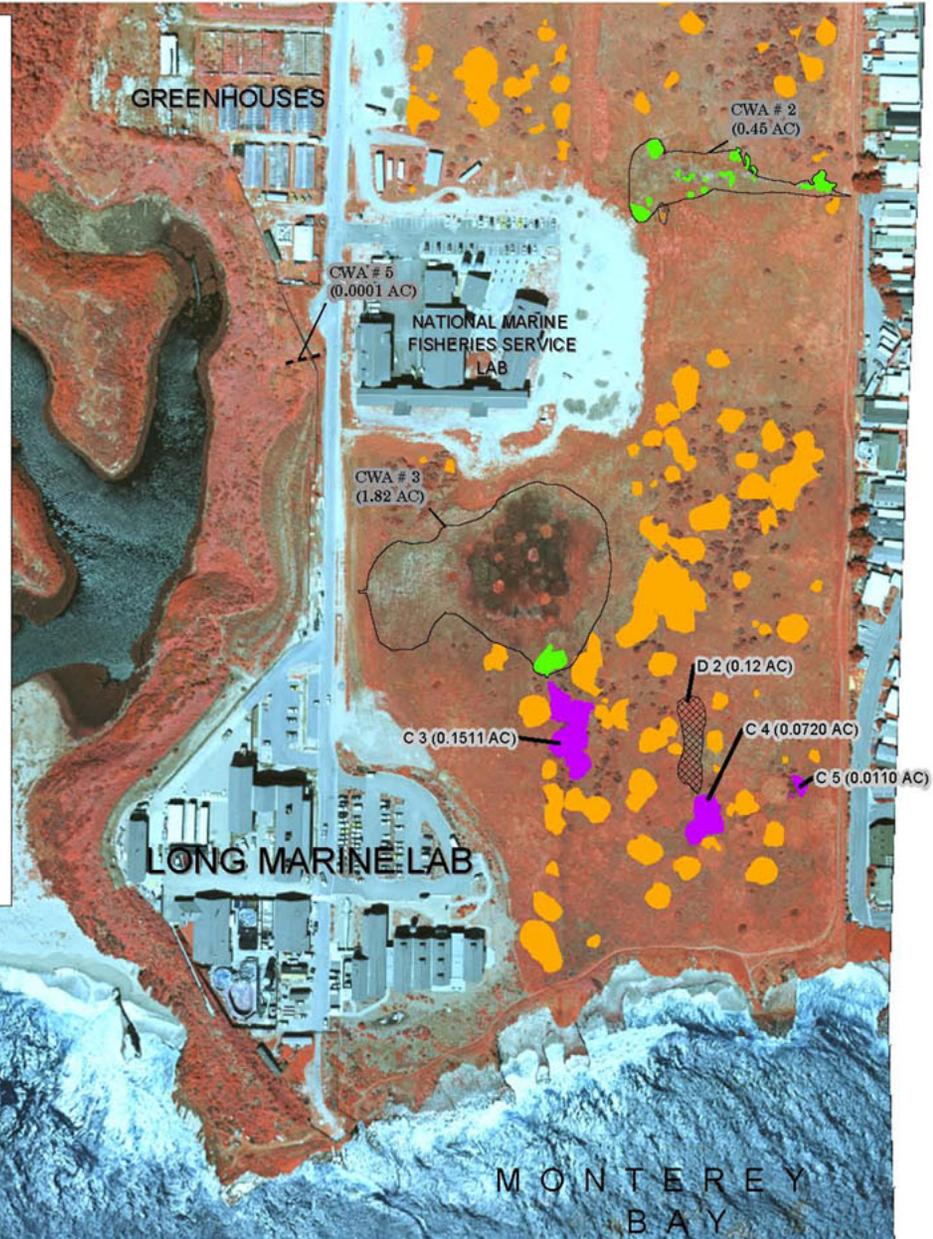
**Map 2B. Current CORPS Verified CWA Wetland Boundaries, And Additional Areas Identified by CORPS/EPA Staff Consideration As Potential Coastal Act Wetlands, Terrace Point, Santa Cruz, CA**

The Corps (Dan Martel) and EPA (Robert Leidy) visited the Terrace Point property at the request of the California Coastal Commission to inspect areas that are subject to Clean Water Act jurisdiction, as well as areas that have a prevalence of hydrophytic vegetation that may, or may not be subject to California Coastal Act jurisdiction as wetlands.

The areas that the Corps and EPA inspected can be put into 4 general categories. The legend on the map/aerial photograph should read as follows:

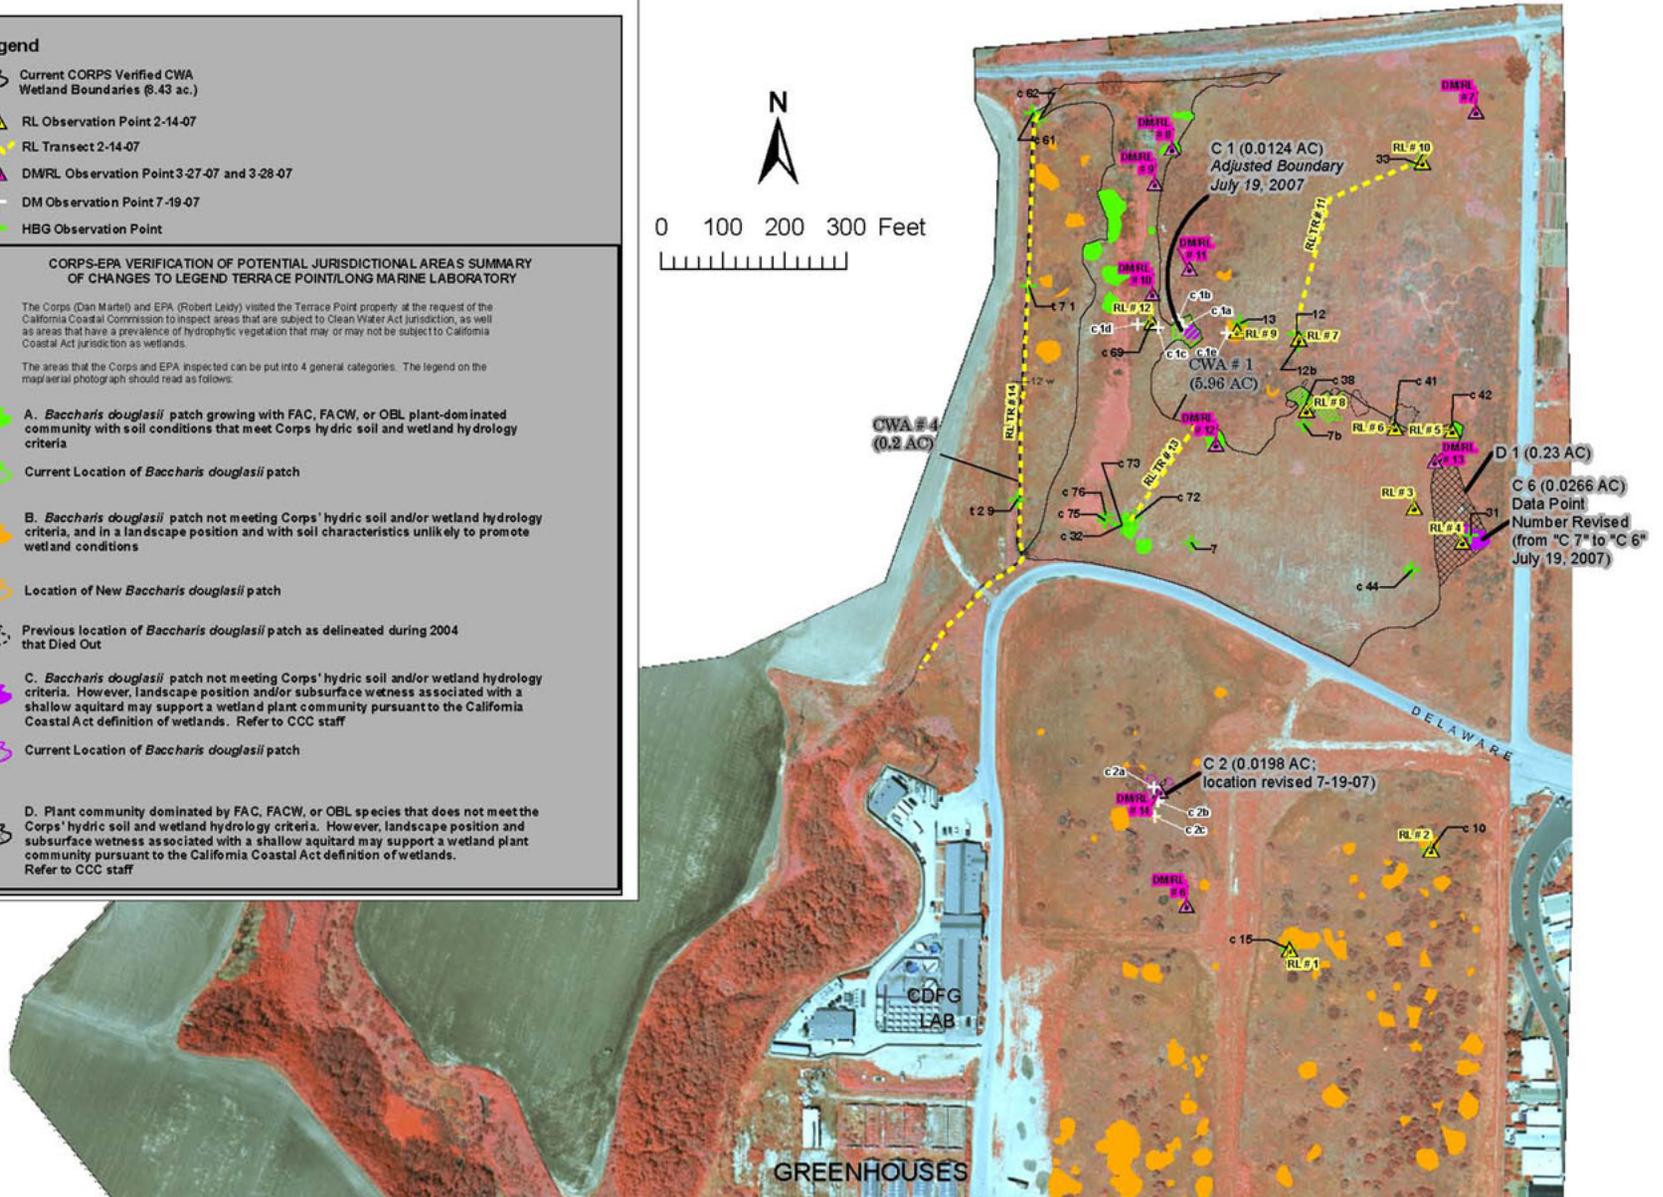
Map 3A. CORPS/EPA Data Points

The Corps (Dan Martel) and EPA (Robert Leidy) visited the Terrace Point property at the request of the California Coastal Commission to inspect areas that are subject to Clean Water Act jurisdiction, as well as areas that have a prevalence of hydrophytic vegetation that may or may not be subject to California Coastal Act jurisdiction as wetlands.

Area D1 (which encompasses *B. douglasii* patch C6<sup>1</sup>) and *B. douglasii* patch C3 are both immediately adjacent to delineated wetlands and fall along a clear moisture gradient from obvious wetland to obvious upland. The *B. douglasii* at C3 occur along the remains of a channel that was dug by a farmer to drain wetland CCC W5 (ACOE CW3). I recommend that both these areas be included as CCC wetlands. The remaining areas that Mr. Martel and Dr. Leidy identified as potential CCC wetlands were thought to be more-or-less isolated, being surrounded by uplands. There are no data for areas D2, C4, or C5 and we did not visit them on July 19, 2007 when I accompanied Mr. Martel and Dr. Huffman in the field. I recommend that these areas simply be identified as "potential CCC wetlands," since their wetland status has no practical consequences due to their location in an area already designated as "open space." We visited the remaining two potential wetland areas (C1 and C2) on July 19 and, at my request, Mr. Martel dug a series of test pits and described the soil and vegetation at each point. The resultant data are attached as Table 1 and the sample points are shown on Map 3.

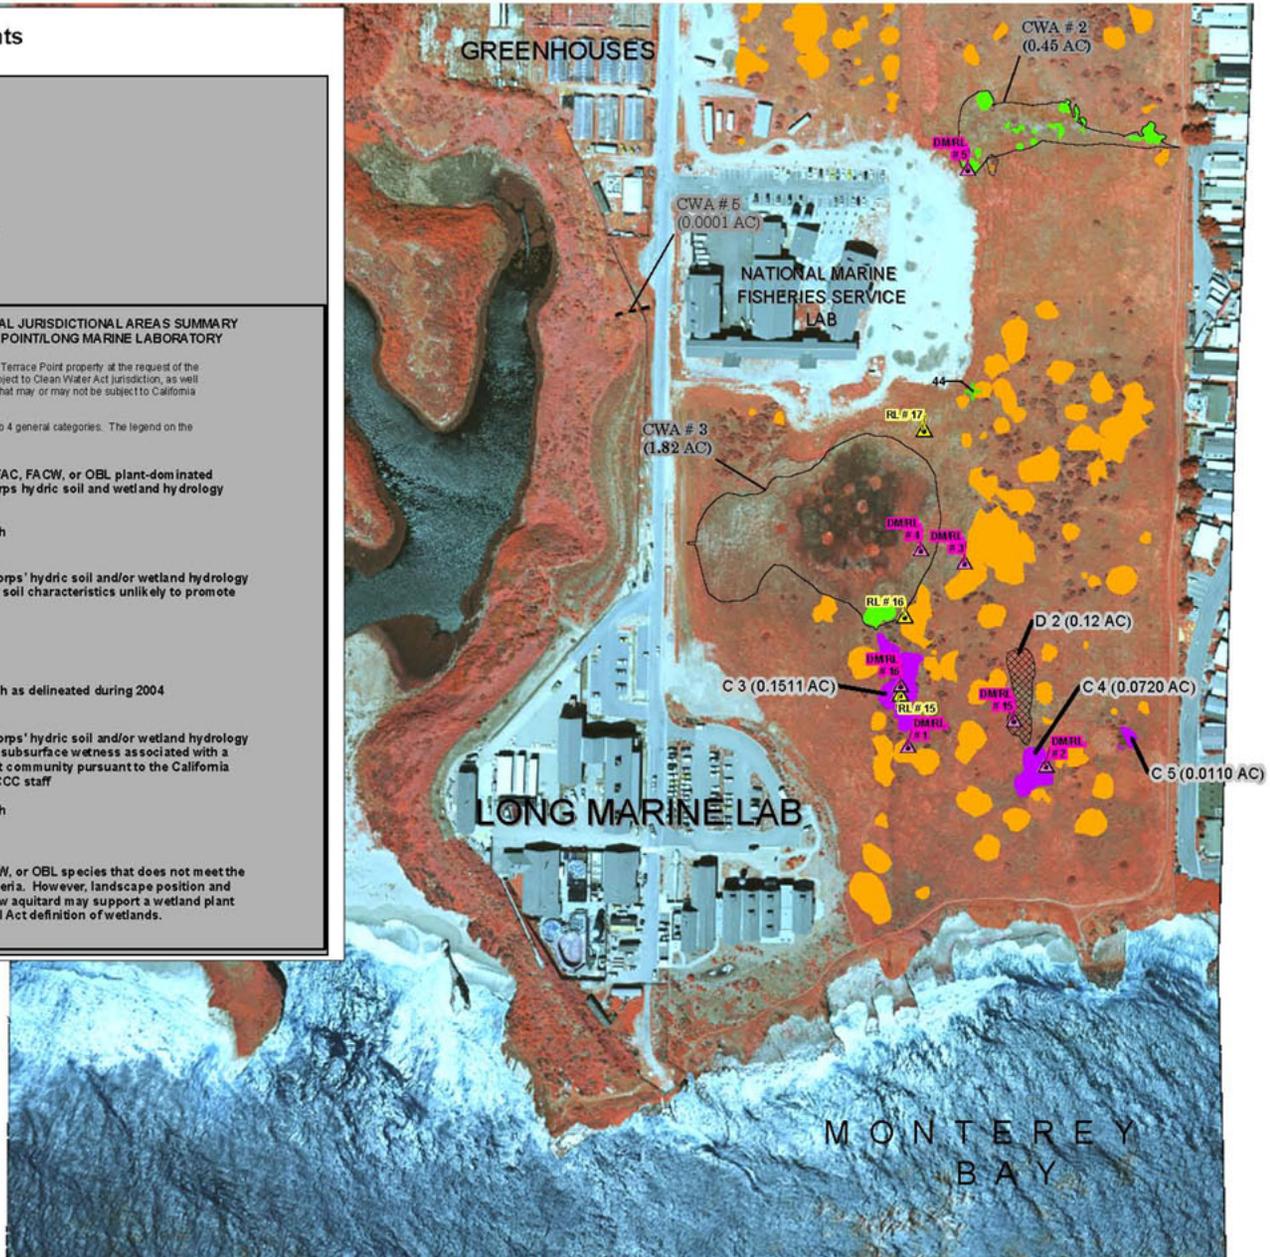
Map 3B. CORPS/EPA Data Points

The Corps (Dan Martel) and EPA (Robert Leidy) visited the Terrace Point property at the request of the California Coastal Commission to inspect areas that are subject to Clean Water Act jurisdiction, as well as areas that have a prevalence of hydrophytic vegetation that may or may not be subject to California Coastal Act jurisdiction as wetlands.
