HUMBOLDT COUNTY LCP AMENDMENT (SAMOA  
TOWN PLAN)

DESIGN GUIDELINES FOR SAMOA, CALIFORNIA  
AREAS SUBJECT TO LCP AMENDMENT REQUESTS  
HUM-MAJ-01-08, PURSUANT TO THE MODIFICATIONS  
SUGGESTED BY THE COASTAL COMMISSION FOR  
CERTIFICATION OF LCP AMENDMENT REQUEST  
HUM-MAJ-01-08 (COLOR VERSION ON COMMISSION'S  
WEBSITE (1 OF 267))

# PART 1: Design Guidelines Old Town, Samoa, California

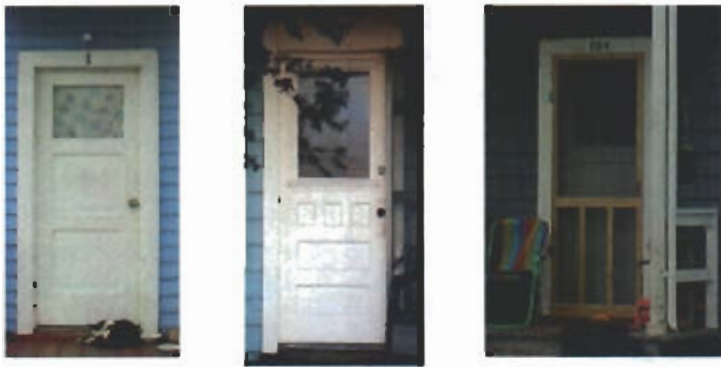
## 2. Doors

Doors are important character-defining features of historic structures that give scale to buildings and provide visual interest to the composition of individual facades. Many historic doors are noted for their materials, placement and finishes. Because an inappropriate door can affect the character of an historic building, one should be careful to avoid radical alteration of an old door and, if needed, choose a new one that is appropriate to the period.

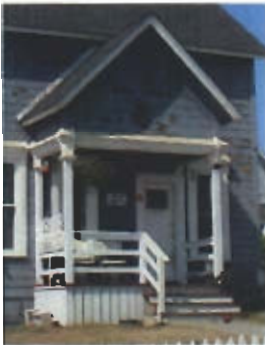
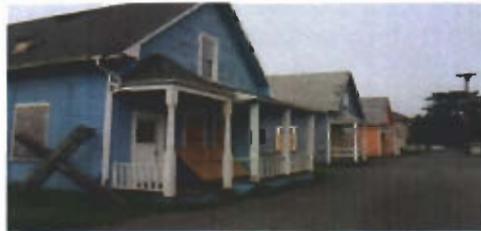
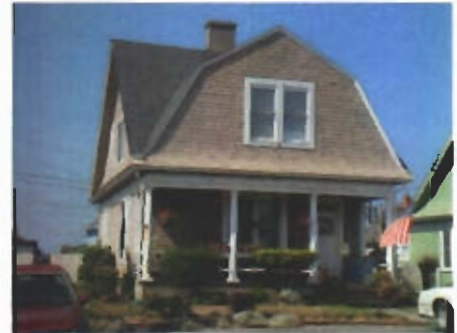
## 3. Wood Porches

Porches can often be the focus of an historic building and, combined with functional and decorative features such as doors, steps, balustrades, pilasters, and entablatures, can be important contributors to the structure's overall character and historical significance. This is especially true in Samoa.

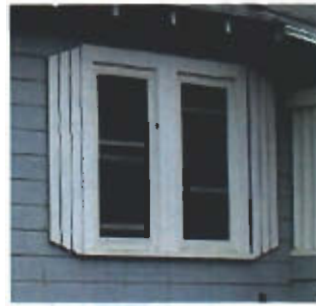
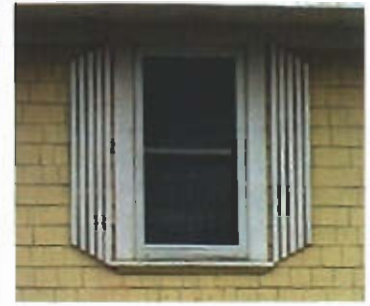
### Shutters

Although shutters exist in Samoa, these examples were primarily added after the period of significance. Nevertheless, it is recommended that existing shutters be maintained and repaired. However, new shutters for other contributing buildings, should be avoided.

Replace only if there is evidence of shutters originally on the building. Use of wood, cedar or redwood, is preferable. Shutters generally should be exactly one-half the width of the sash and installed with hinges. Construction of shutters shall be louvered, paneled, or constructed in the same style of the building.

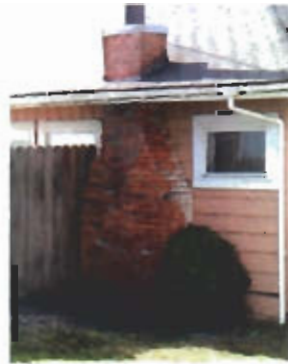
## Chimneys

Chimneys in Samoa are primarily constructed of brick with variations in the design of the flue. Original brick and masonry should be retained and repaired as possible.

If replacement is required, use same brick type if fireplace was historically evident. When replacing a non-historical system, replace with an efficient contemporary system.

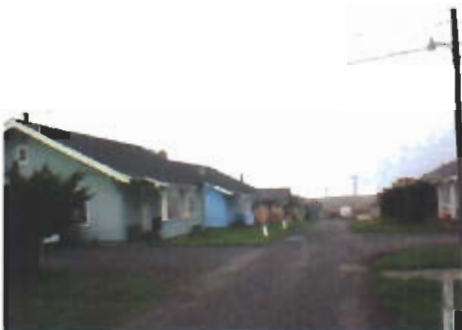
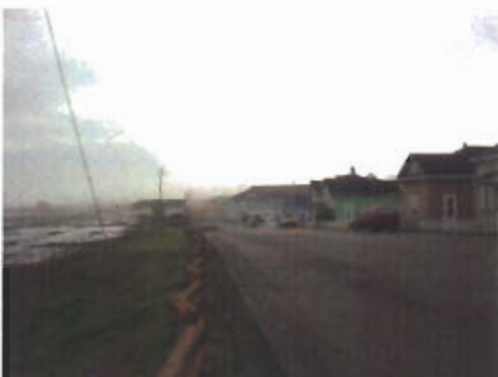
**Sidewalks.** Many of Samoa's streets were designed before the advent of the automobile and, as such, do not have sidewalks. Adding sidewalks to these roads would significantly impact this character-defining feature.

- If new sidewalks are necessary, use surface materials to complement the historic and cultural character of the area. Consider a texture and color that is more suited to town atmosphere if this new material is used. Sidewalk surfaces shall be weathered by hosing and brushing with a stiff broom to expose the aggregate prior to concrete fully setting. Alternative

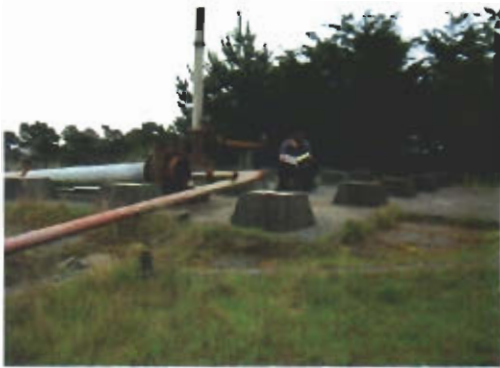
### **Water Tower**

Reconstruction of water shall be done in accordance with plans available for the original building. However, materials may be substituted that best reflect the building's character defining features. An appropriate use, interpretation, and signage will also be determined.

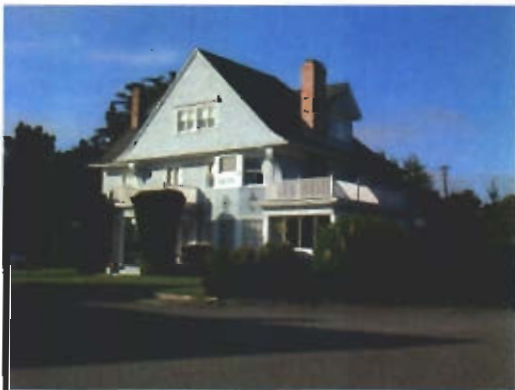
### **Hostelry**

The Hostelry, or "Mansion", is the original home of Hammond Lumber Mill. Built in a grander and more ornate style than the workers' housing, this building has been renovated. Ongoing maintenance in accordance with the Samoa Design Guidelines is required.
