HUMBOLDT COUNTY LCP AMENDMENT (SAMOA TOWN PLAN)
PART 1: DESIGN GUIDELINES FOR SAMOA, CALIFORNIA
AREAS SUBJECT TO LCP AMENDMENT REQUESTS HUM-MAJ-
1-08, PURSUANT TO THE MODIFICATIONS SUGGESTED BY
THE COASTAL COMMISSION FOR CERTIFICATION OF LCP
AMENDMENT REQUEST HUM-MAJ-01-08 (COLOR VERSION ON
COMMISSION'S WEBSITE (1 of 267)

FINAL DRAFT Revised March 4, 2007

PART 1: Design Guidelines Old Town, Samoa, California

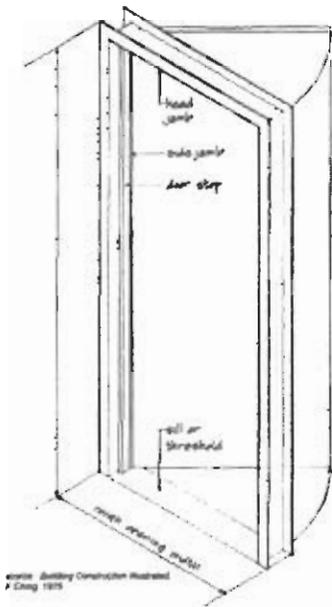
Step 1: Identify Door Types & Features

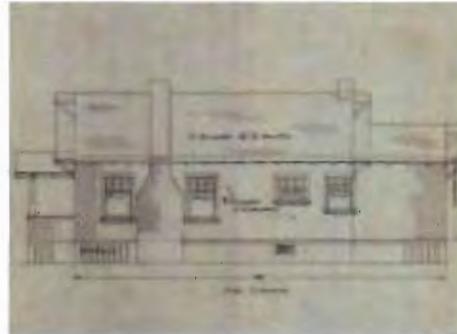
Chimneys

Chimneys in Samoa are primarily constructed of brick with variations in the design of the flue. Original brick and masonry should be retained and repaired as possible.

If replacement is required, use same brick type if fireplace was historically evident. When replacing a non-historical system, replace with an efficient contemporary system.

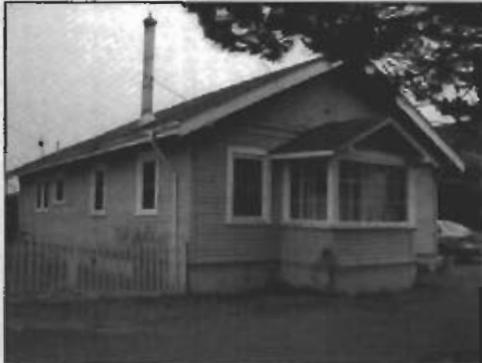
7 Samoa Court Extension

1. Simple Front Gable with Low Pitch: 30%

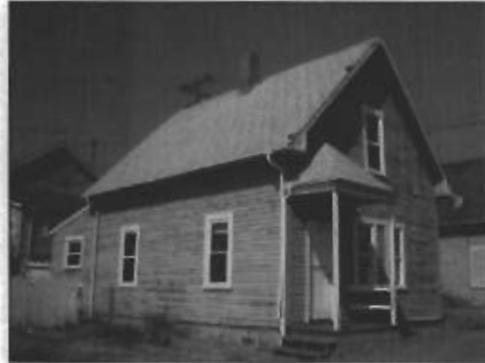
11 Cadman

2. Simple Front Gable with Moderate Pitch, 1.5-2 story: 18%

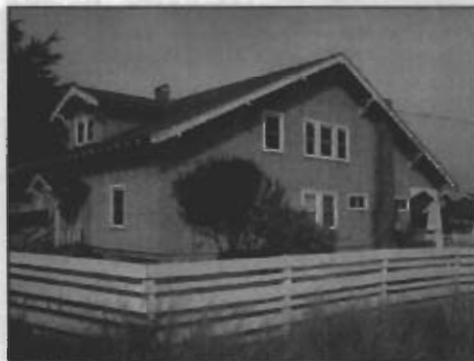
9 Samoa Court Extension

3. Large Front Gable over 2 Stories with Side Gabled Dormer: only 1 (1%)

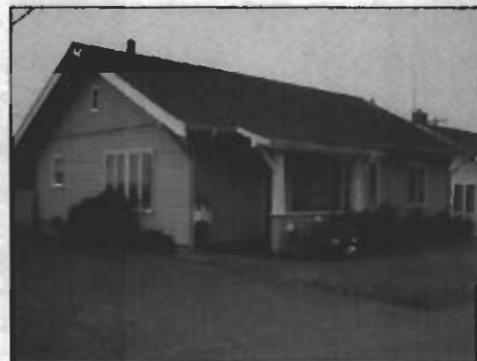
125 Sunset

4. Simple Side Gable with Low Pitch (1 story): 15%

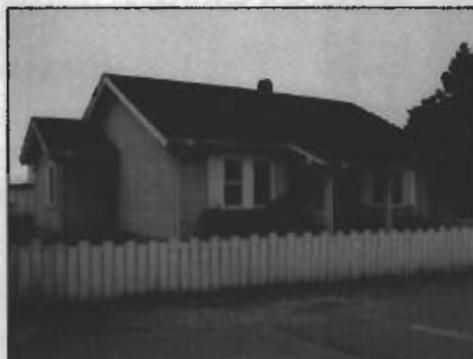
9 Samoa Court Extension

5. Simple Side Gable with Low Pitch and Small Extension (1 story): 6%

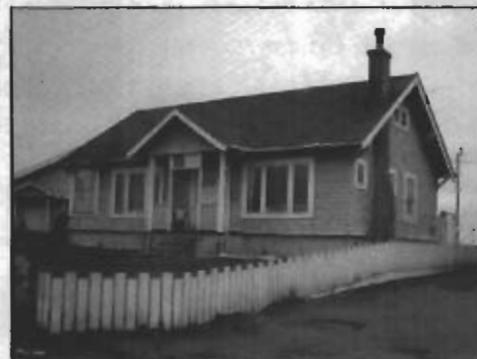
9 Samoa Court Extension

6. Simple Side Gable with Moderate Pitch (1.5 story): only 1 (1%)

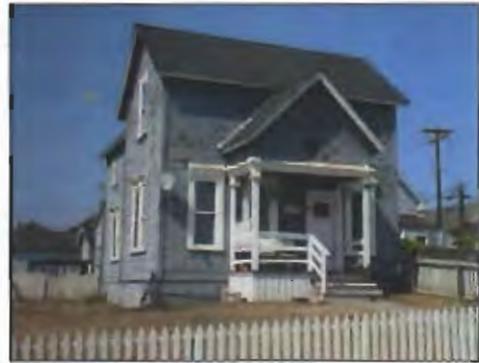
13 N Bayview

8. Cross-Gabled 2 Story Roof stepping down to Shed Roofed Rear Wing: only 1 (1%)

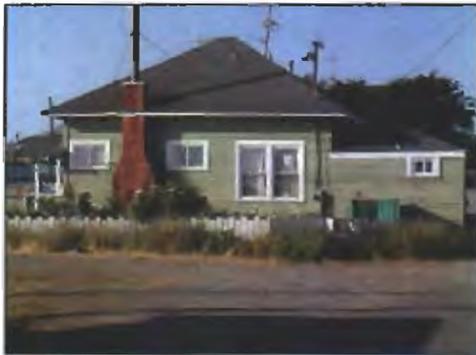
14 Murphy

9. Near-Pyramidal Ridge Hip over 1 Story: 6%

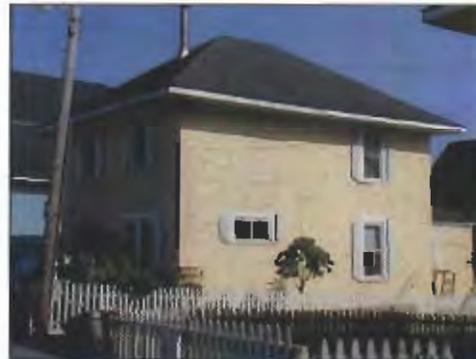
3 Rideout

10. Near-Pyramidal Ridge Hip over 2 Story: 5%

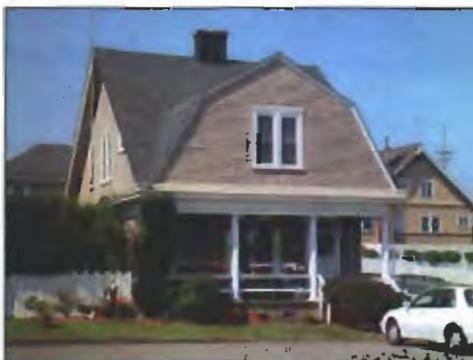
19 Vance

11. Side-Gabled with Cross-Gambrel over L-Shaped 2 Story: 5%

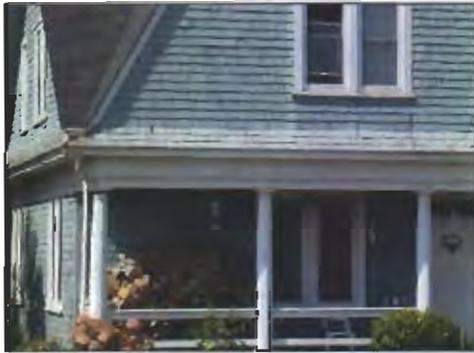
17 Vance

20. Trim Band at Midline: 4%

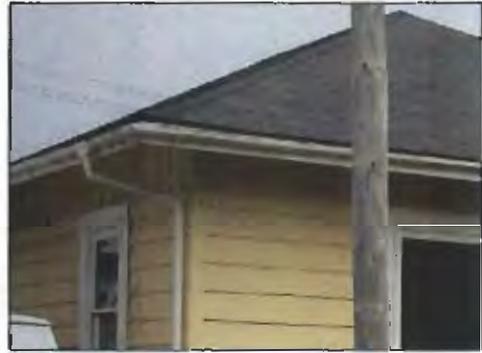
124 Sunset

21. Strip of Vertical Board and Batten Panelling under Eve: 4%

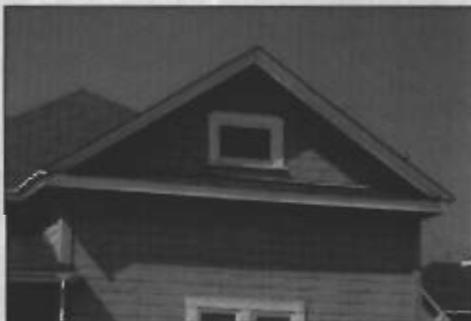
21 N Bayview

26. Pedimented Main Gable: 2%

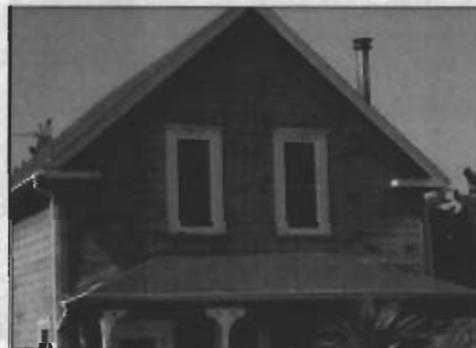
111 N Bayview

27. Broken Pediment on Main Gable: 2%

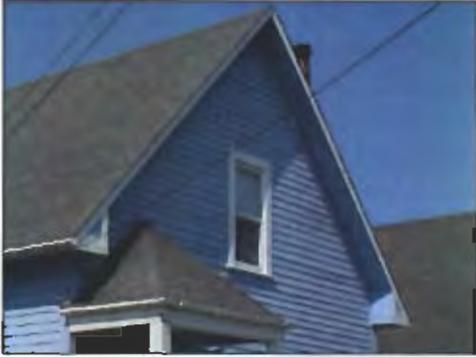
1 Samoa Court

30. Pork Chop Eaves: 12%

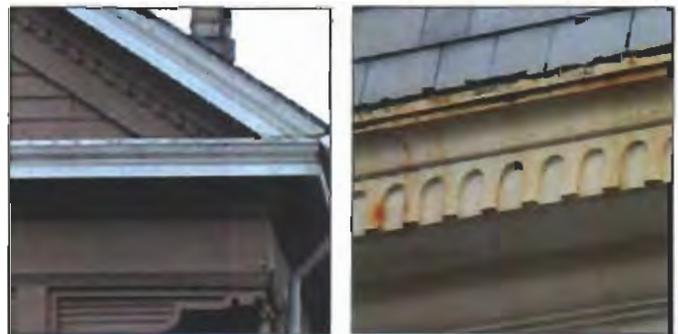
108 N Bayview

35. Dentil Work

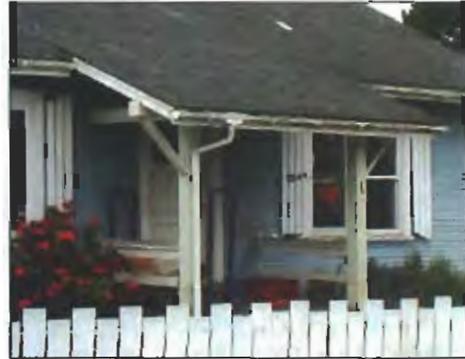
1 Fenwick

55. Exterior Gable Extension, Form 1: 4%

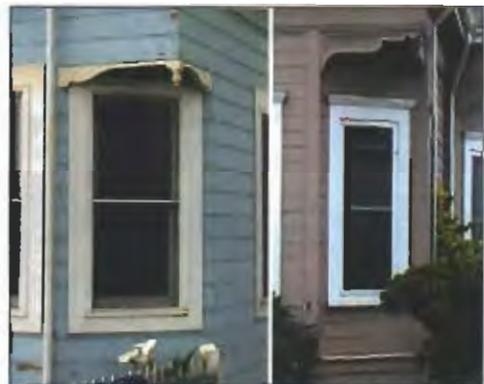
11 N Bayview

99: Corner Angled under Ornamented Overhang: 2%

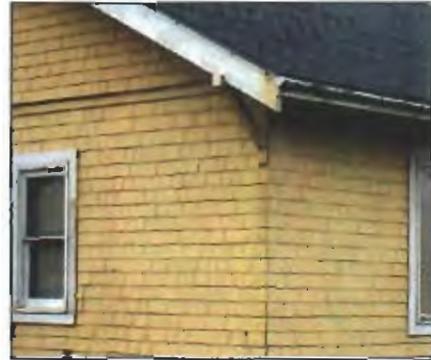
137 Sunset

110. Square Shingled: 29%

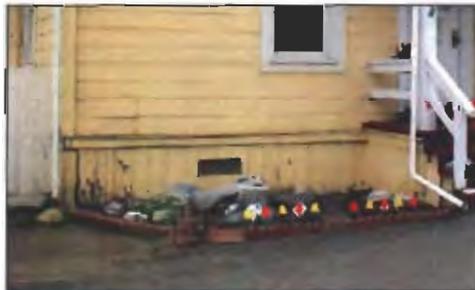
16 Fenwick

111. Pier-Raised with Vertical Skirt Cladding: 70%

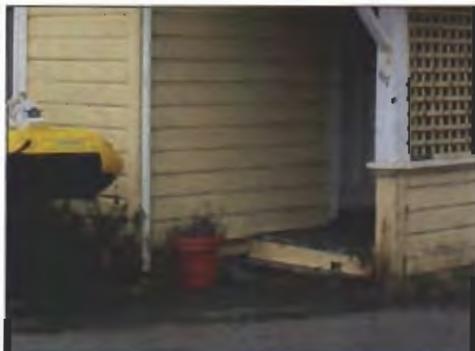
117 Sunset

113. Low Pier-Raised with tiny Skirt or no Skirt: 15%

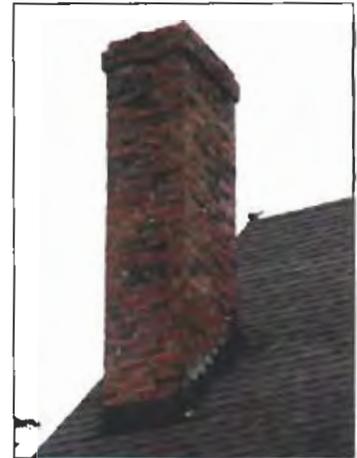
Hostelry

135. Clinker Brick Chimney:
1%

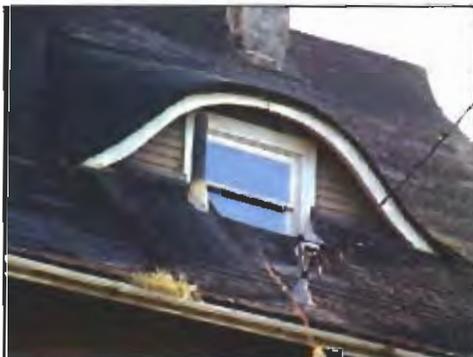
110 Rideout

136. Eyebrow Dormers: 2%

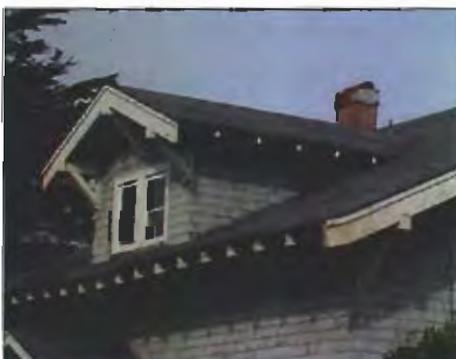
9 Samoa Court Extension

138. Craftsman Gable Dormers: 1%

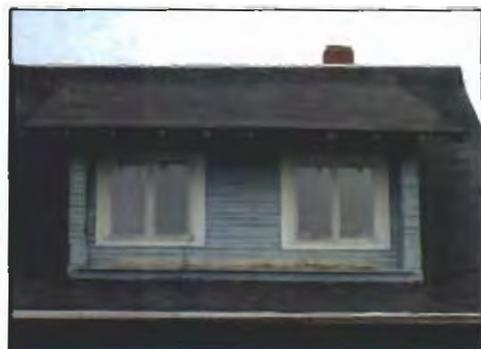
112 Rideout

139. Shed Dormers: 2%
