5-12-263-A1 (Los Angeles World Airports)

Revised Ecological Landscape Plan For the Los Angeles International Airport Coastal Dunes Improvement Project City of Los Angeles, California

April 2021

Prepared for: Los Angeles World Airports and the California Coastal Commission
Prepared by: The Bay Foundation, Coastal Restoration Consultants, and
California Botanic Garden

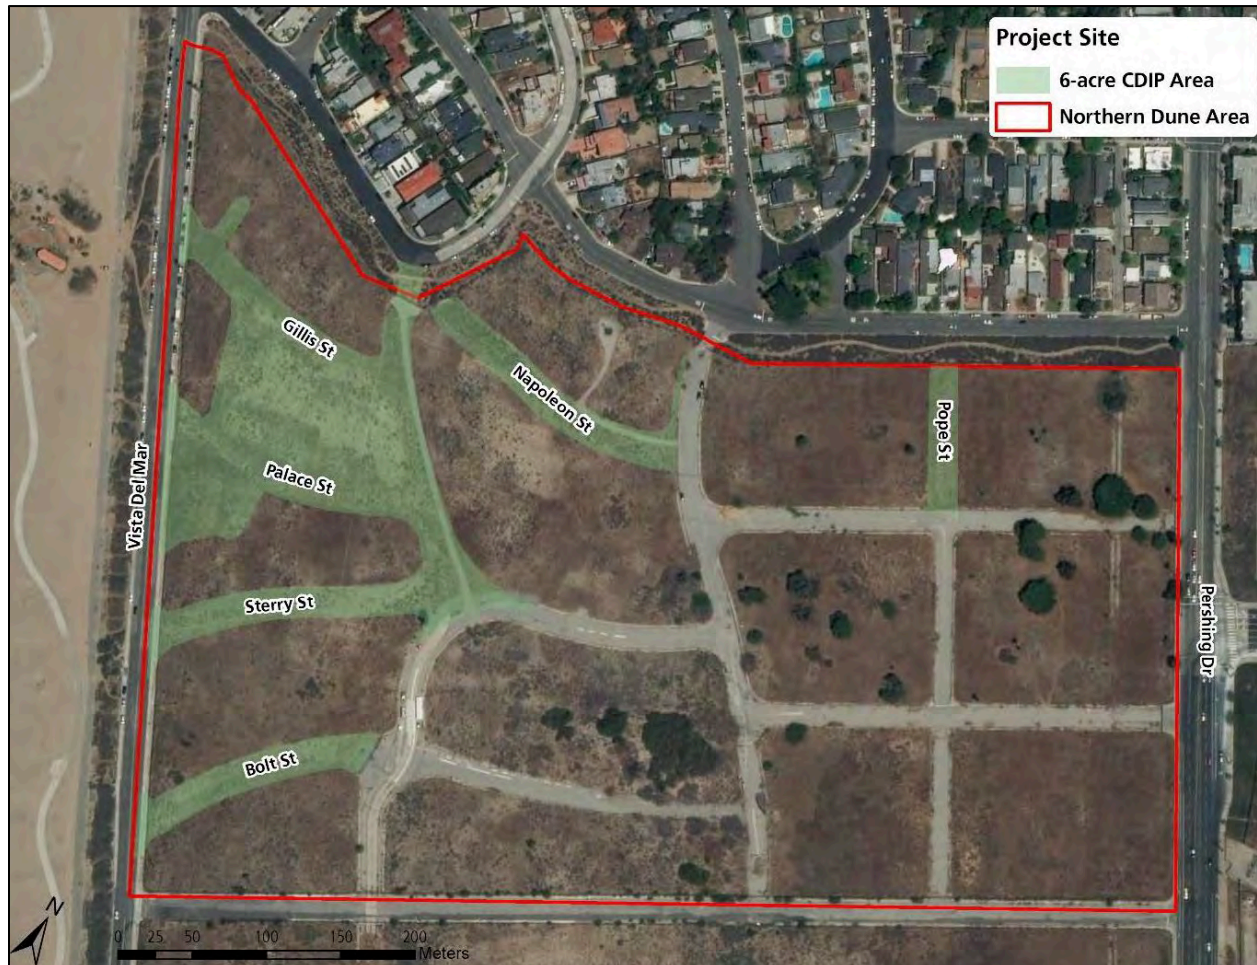
Figure 1. Northern LAX Dunes (48-acres) and CDIP project area.

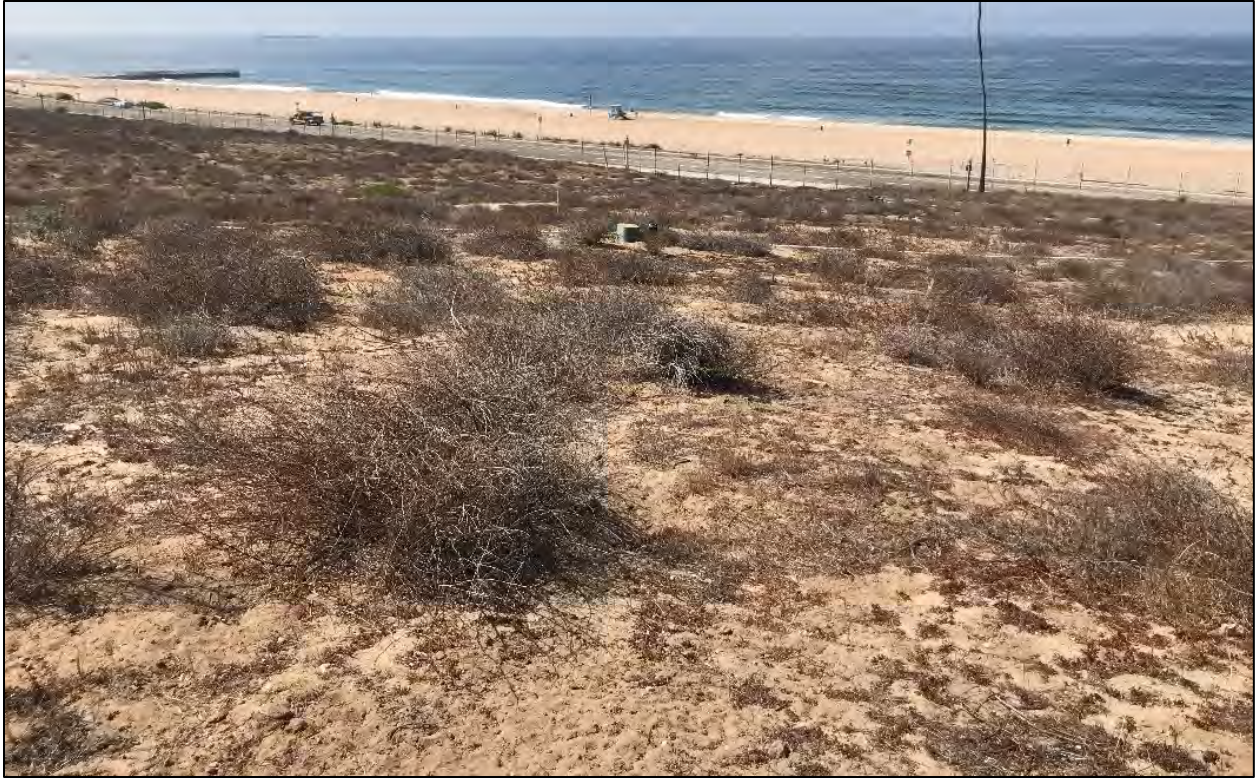
Figure 2. Existing vegetation in the CDIP restoration site (23 August 2018). The shrubs are mostly native *Acmispon glaber* (deer weed) and the majority of the low-growing vegetation is non-native *Erodium* spp. (filaree).

After construction activities ended in 2014, the majority of the six-acre CDIP site was vegetation-free. Early restoration efforts included seeding (at a low rate), irrigating, and weeding. By 2019, when the site was surveyed by TBF, targets set in the 2013 Ecological Landscape Plan were largely being met, but there were several areas that were challenged by non-native invasion. TBF and LAWA have conducted weeding of the site, primarily through community restoration events and some maintenance activities by LAWA staff, since 2014. While cover of non-native annuals remains higher than desirable, the CDIP area is almost entirely free of invasive perennial non-natives such as *Carpobrotus* spp. (iceplant) and *Acacia cyclops* (wattle). *Euphorbia terracina* (carnation weed), which is scattered in some parts of the site, is the primary invasive perennial in need of control. In general, the limited seeding and subsequent weeding efforts have moved the project towards success, but further introductions of native plants and continued weeding will be needed to restore natural, self-sustaining dune communities. Detailed information on the current conditions of the six-acre restoration area are detailed in the Ecological Monitoring Report (2018) and the 2020 Annual Progress Report (TBF 2020). The areas shown in Figures 2 and 3 are representative of current conditions, with *Acmispon glaber* (deerweed) as the dominant shrub surrounded by patchy non-native annuals.

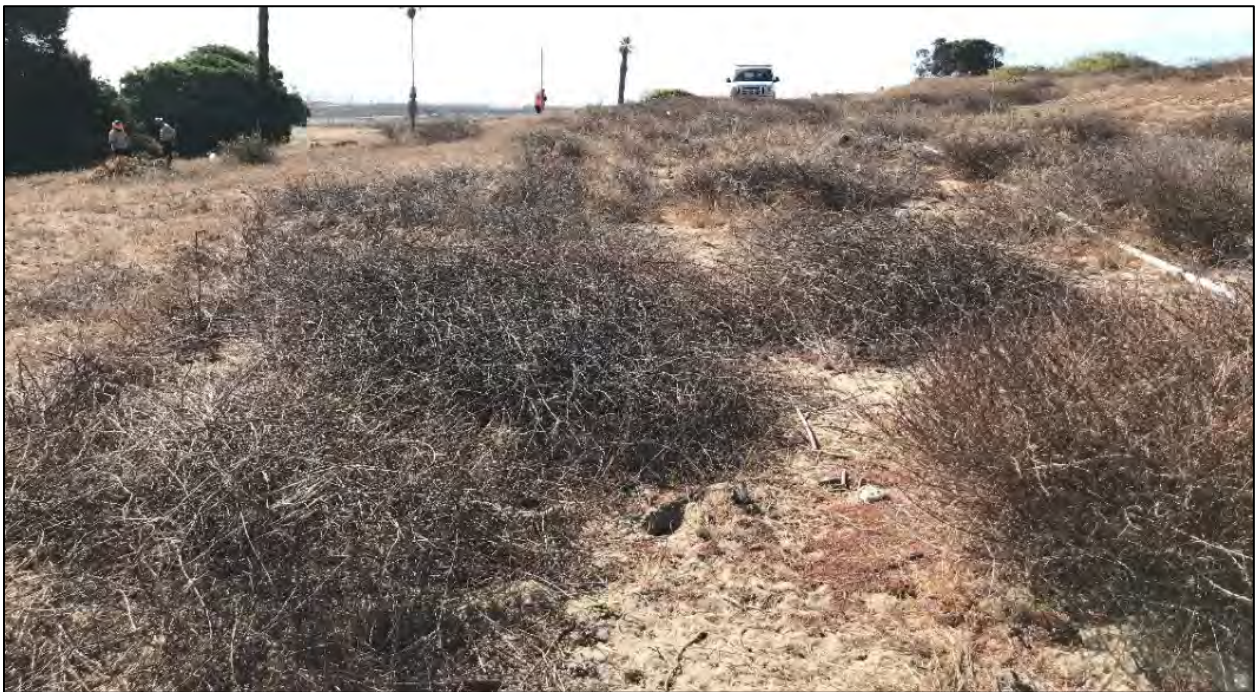
Figure 3. Existing vegetation in the backdune (Pope St) portion of the CDIP restoration site (23 August 2018). The shrubs are mostly *Acmispon glaber* (deer weed) and the majority of the low-growing vegetation is *Erodium* spp. (filaree) and *Bromus* spp. (Brome grass).

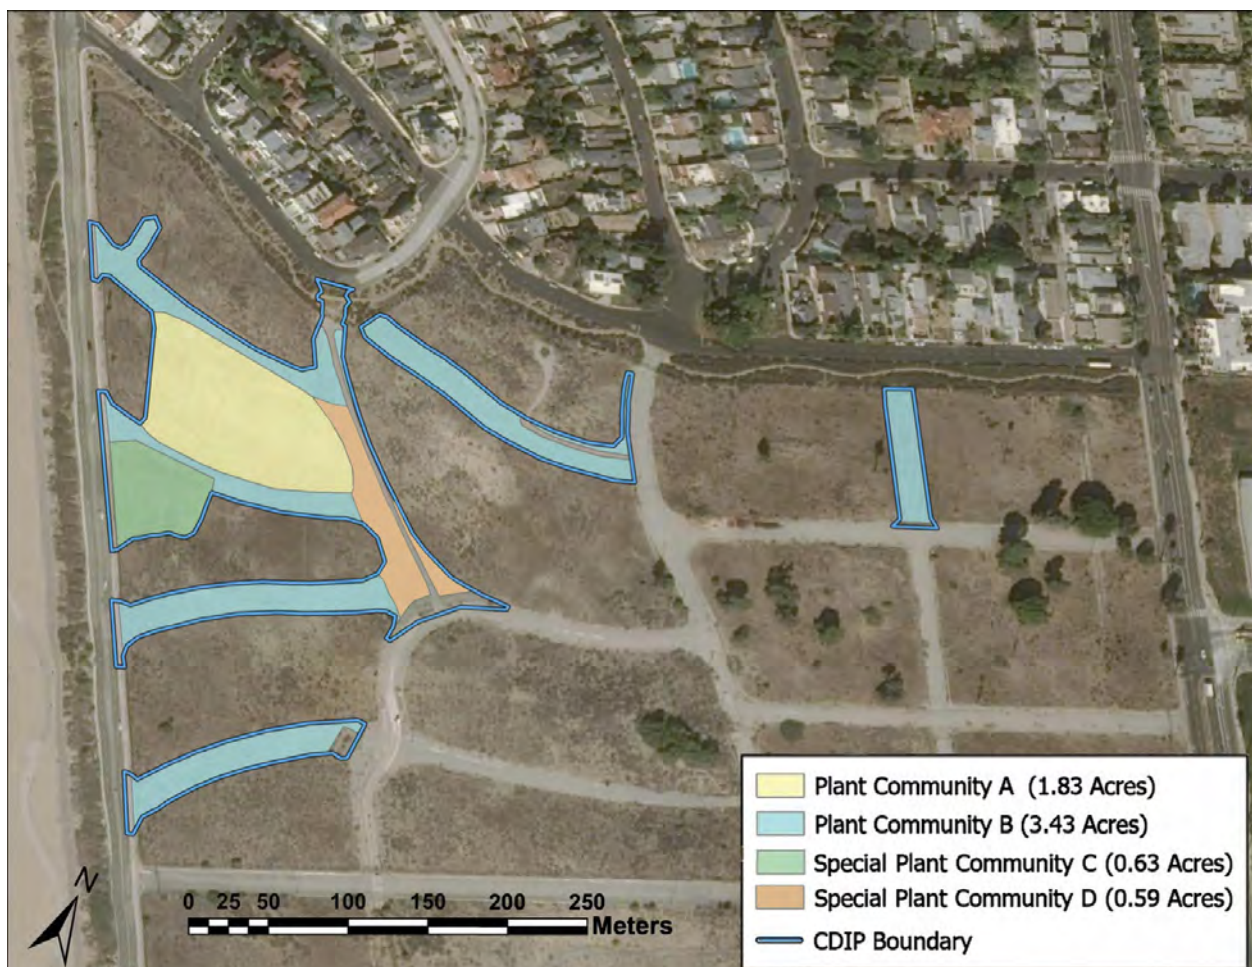
Figure 4 displays the four Plant Community planting areas. The natural sandy soils in Plant Community A will support both Southern Foredune and Southern Dune Scrub habitats. Other soils will support a mixture of species from both Coastal Sage Scrub and Southern Dune Scrub habitats (Plant Community B and Special Plant Communities C and D).

Figure 4. CDIP Plant Community four planting areas (i.e., Plant Community A-D).

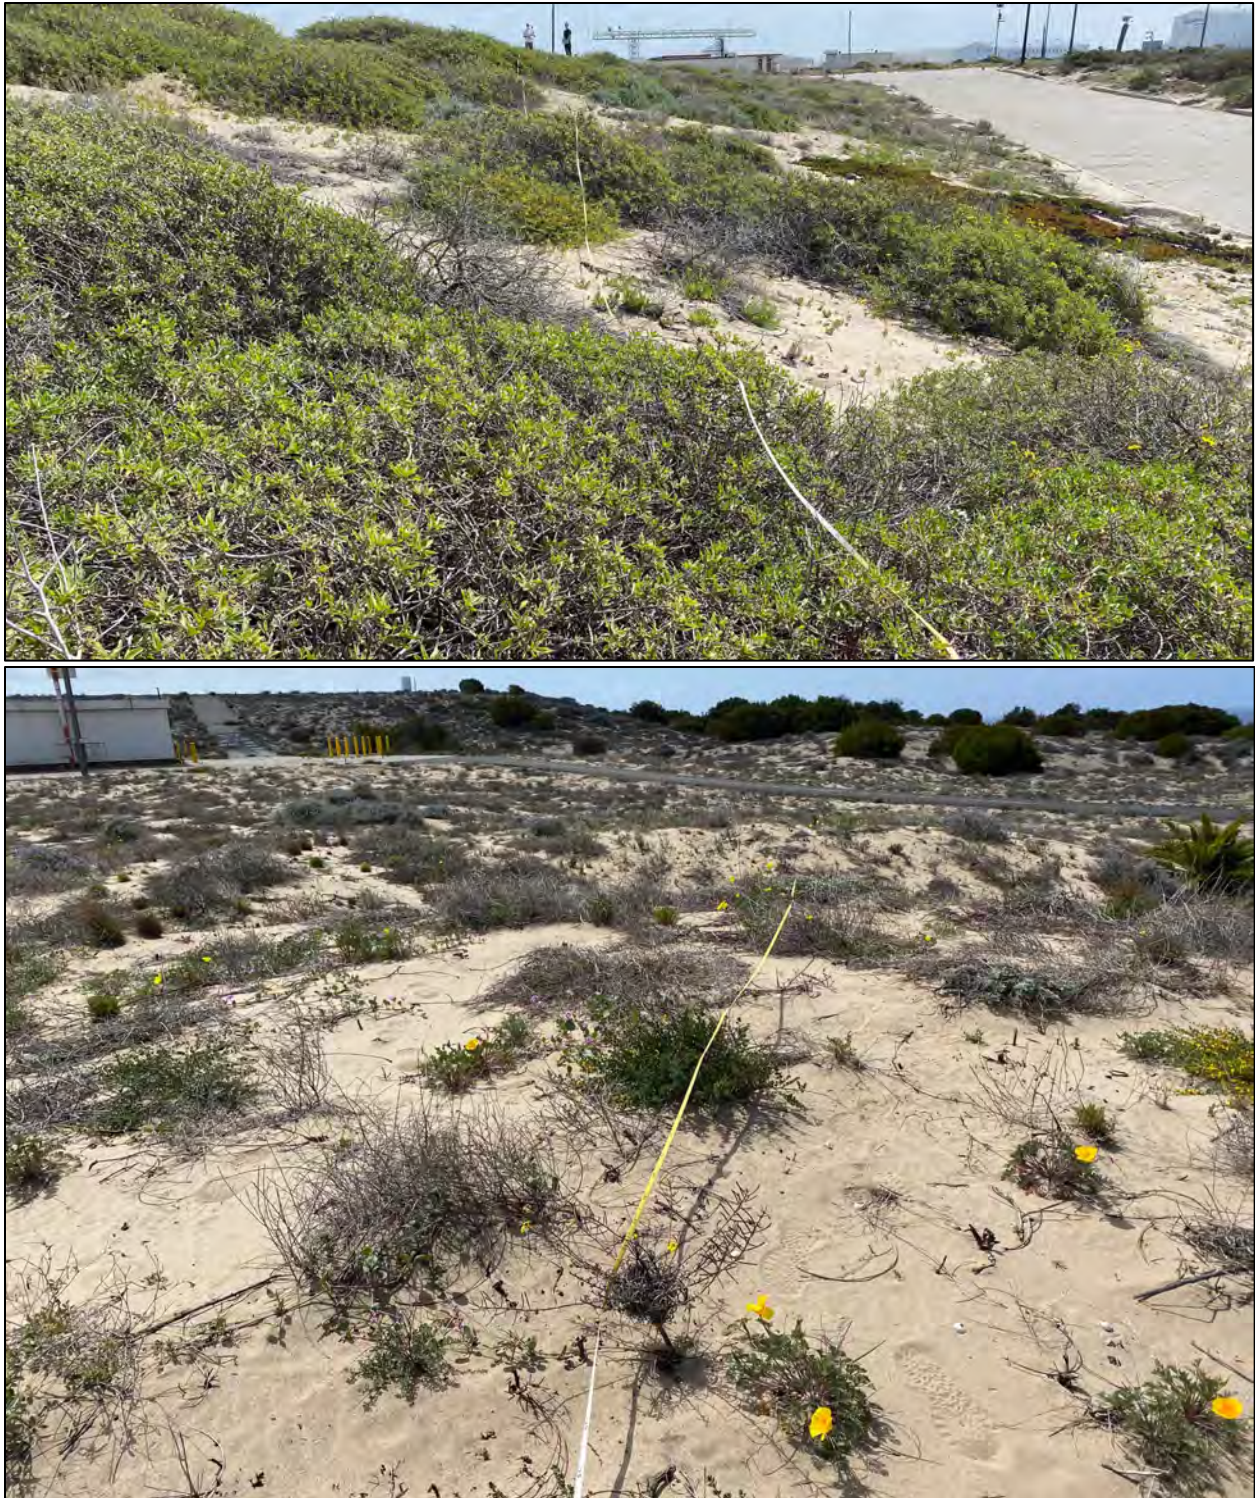
Four 50-meter reference transects were selected for each of the two target habitat types: Southern Foredune/Southern Dune Scrub and Coastal Sage Scrub/Southern Dune Scrub (8 total reference transects). All transects had well-established native plants and relatively low non-native plant cover. A 1 X 1m quadrat will be placed at 2-meter intervals along the transects (50 meters), to generate 25 quadrat sample areas per transect, and 100 quadrat sample areas per reference habitat type. Figure 5 displays example photos of one transect from each reference habitat type.

Figure 5. Example photo of Coastal Sage Scrub/Southern Dune Scrub reference transect (top) and Southern Foredune/Southern Dune Scrub reference transect (bottom).
